Hi-Fi Products
Service Bulletin

Model: CDP-411

No. 397

Subject: "No Disc" Appears during Play

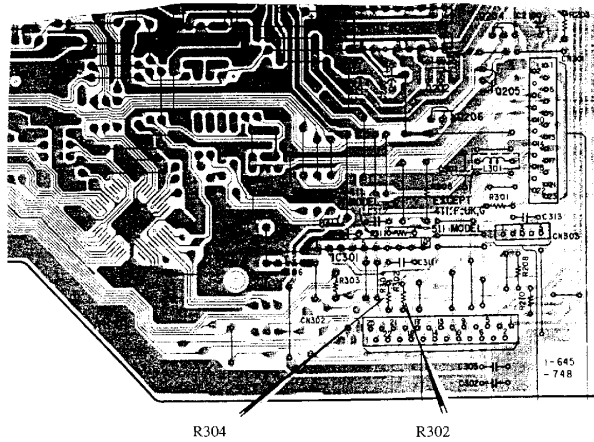
During the Continuous play mode a "No Disc" indication will appear in the display.

Change the value of the parts listed below.

REF	FORMER		NEW	
	DESCRIPTION	PART NUMBER	DESCRIPTION	PART NUMBER
R304	1K OHM	1-249-417-11	330 OHM	1-249-411-11
R302	1K OHM	1-249-417-11	470 OHM	1-249-413-11
