**Model:** CPD-15SF2, CPD-17SF2**No.** 142**Subject:** OSD Missing or Displayed Incorrectly**Date:** January 6, 1997**Symptom:****(122)**

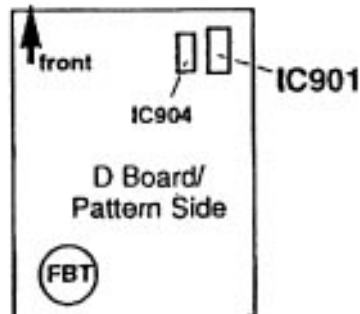
**IC901 LOCATION**

If the On Screen Display (OSD) is not showing or is displayed incorrectly. This occurs especially when the Input Video Vert. Freq. is 99.5 -100 Hz. This may be caused by CPU IC901 on the D Board.

Then please replace IC901 on the D Board. Refer to illustration shown below.
