# Computer Monitors Service Bulletin

**CSI-111**

**Model:** GDM20SE1

**Subject:** Preventive Measure to protect R-850

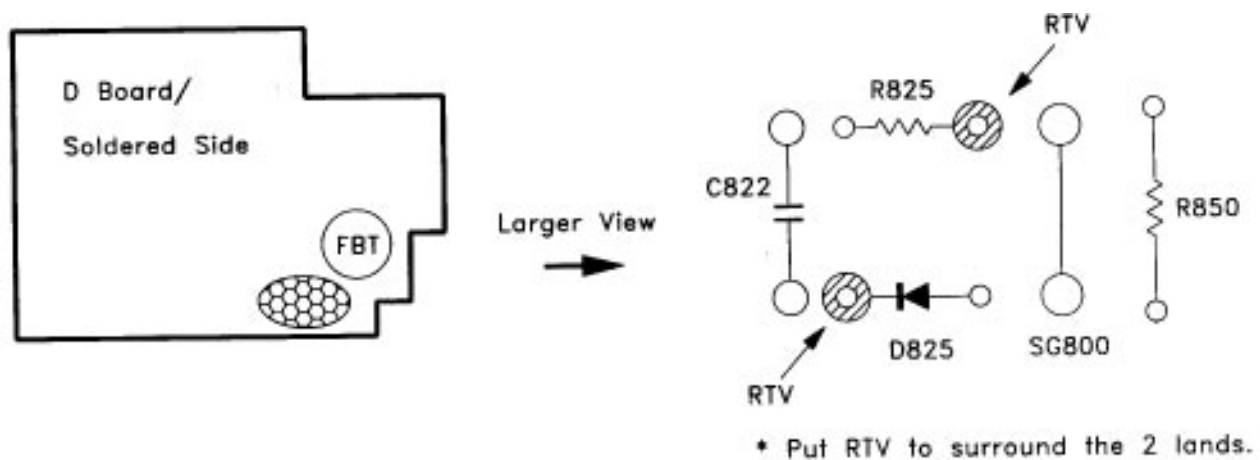
- 3 Apply RTV to the lands indicated by stripes in the figure below:

To prevent the possibility that R-850 on the D-Board will open, perform the following circuit change:

- 1 Replace C-822 with the following new part.
- 2 Replace R-850.
