Service Bulletin Camera/Camcorder

No. **506**

Subject: Caution when replacing the VC-213 board.

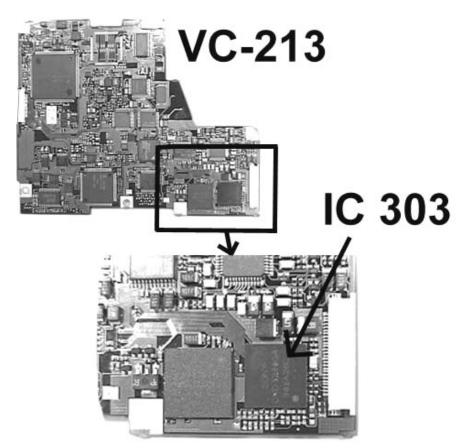
There are two types of DV Interface IC303 on the VC-213 boards; one is Sony and the other is TI. Both manufacturer names are labeled on the top of the IC. Whenever the board is replaced, the proper page C, address AD data must be installed. Incorrect data will result in NO DV IN/OUT.

When IC303 is Sony, verify that data 00 is at page C, address AD. When IC303 is TI, verify that data 02 is at page C, address AD.
