## Replace Front Fender Garnishes

Classification	Repair Bulletin	Section/Group	12 - Exterior Fittings	Country/Region	United States
Year	2016	Model	Model X	Version	All

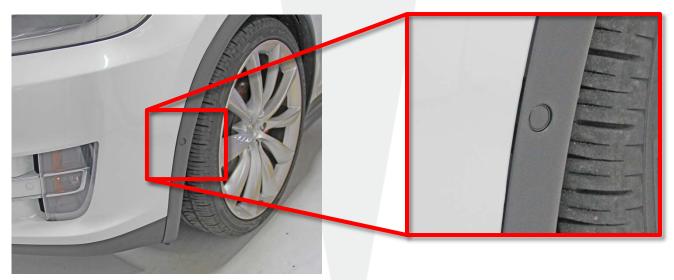
Figure 1

The parking sensors might not be flush with the front fender garnishes (Figure 1) on some Model X vehicles, causing a perceived quality issue.

Upon customer complaint, replace both front fender garnishes.

1. Remove and discard the LH front fender garnish assembly (refer to Service Manual procedure 12201202).

NOTE: The new front fender garnishes come with the parking distance sensor and retaining ring already installed.

- 2. Ensure that the parking sensor is flush with the new fender garnish.
- 3. Install the new front fender garnish.
- 4. Perform steps 1-3 on the RH side of the vehicle.
