Tesla, Inc. Service Bulletin		<i>Rectify Regulatory Labels for Mexico, Model 3</i>	
SB-19-19-007 September 24, 2019			
Classification		Section/Group	Mobile Service
Campaign Bulletin		19 - Labels	Can Perform* *Where permitted
Model Year	Model	Country/Region	Version
2019	Model 3	Mexico	All
<small>The model(s) and model year(s) listed are a general approximation of the affected VIN list. Refer to the VIN/Bulletin Tracker or Customer/Vehicle profile to determine applicability of this bulletin for a particular vehicle.</small>

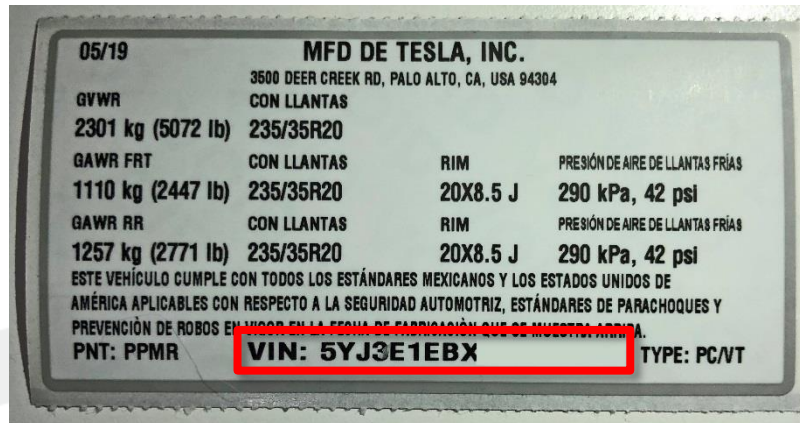
Figure 1

NOTE: The manufacturer certification label is specific to a Vehicle Identification Number (VIN) (Figure 1). Replacement labels have been shipped directly to the Service Center.

NOTE: The Tire and Loading Information label is specific to a VIN (Figure 1). The last 6 digits of the VIN on the label (Figure 3) should match the VIN of the vehicle. Replacement labels have been shipped directly to the Service Center.

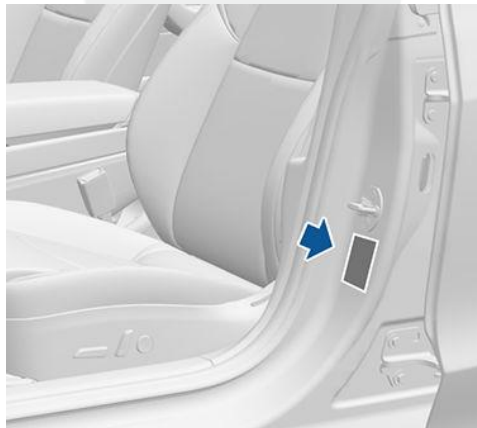
Figure 2

1. Open the driver's door and locate the manufacturing certification label near the base of the B-Pillar (Figure 2).

2. Retrieve the updated vehicle-specific manufacturer certification label for the vehicle.
3. Inspect the new manufacturer certification label and check that the VIN matches the dashboard VIN plate.
4. Starting from one corner, carefully peel the manufacturer certification label off the B-Pillar using a plastic trim tool. Discard the label.

5. Use an Isopropyl Alcohol (IPA) wipe to remove any remaining adhesive or label shreds. Allow the alcohol to completely dry before continuing.
6. Install the updated manufacturing certification label in the same location.

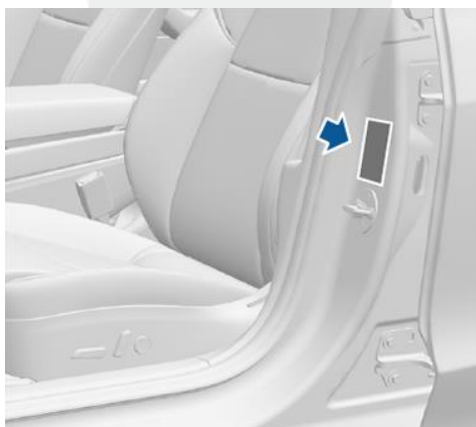
Figure 4

1. Locate the Tire and Loading Information label near the base of the B-Pillar (Figure 4).

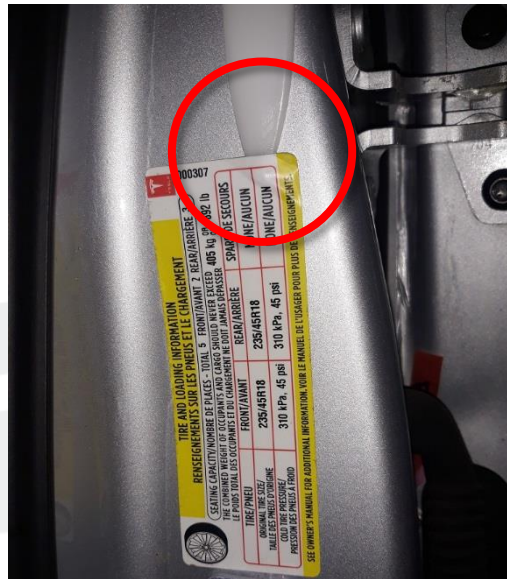
Figure 5

- Starting from one corner, carefully peel the Tire and Loading Information label off the B-Pillar using a plastic trim tool (Figure 5). Discard the label.

- Use an IPA wipe to remove any remaining adhesive or label shreds. Allow the alcohol to completely dry before continuing.
- Install the updated Tire and Loading Information label in the same location.

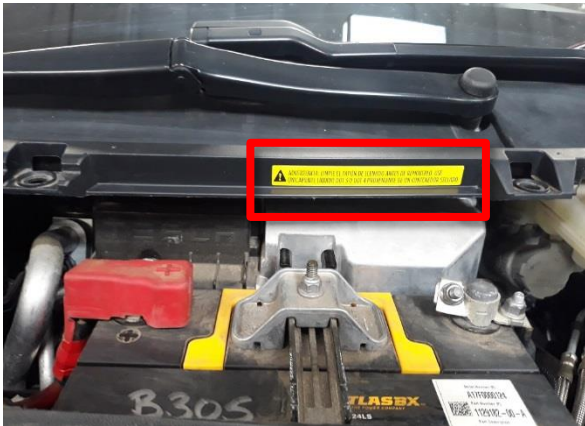
✓ Figure 7

- If the brake fluid label is present (Figure 7), skip to step 7.
- If the brake fluid label is not present (Figure 8), continue to the next step.

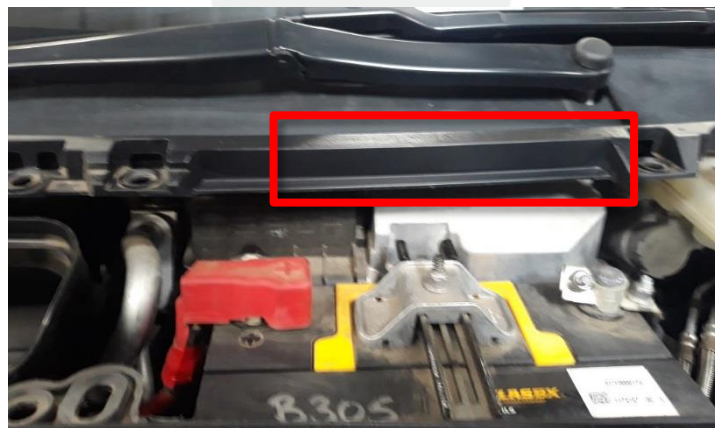
5. Clean the cowl screen area highlighted in Figure 9 with an IPA wipe. Allow the area to completely dry before continuing.

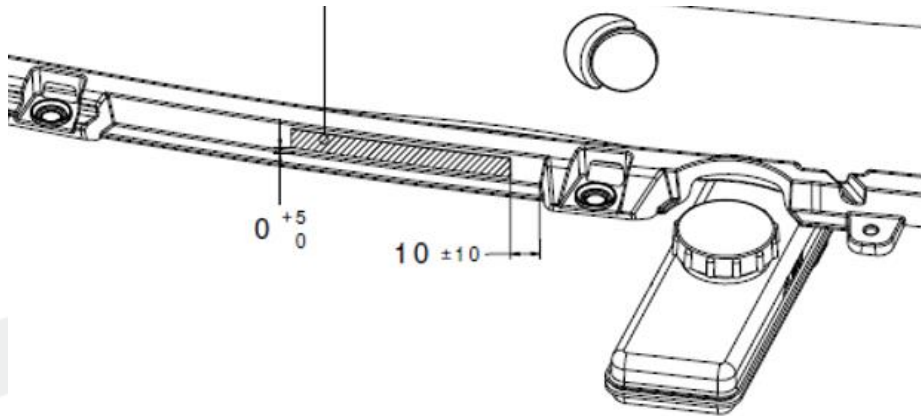
Figure 10

6. Install the supplied brake fluid label to the cowl screen approximately 10mm +/- 10mm from the LH side edge and 0-5mm from the bottom edge (Figure 10).

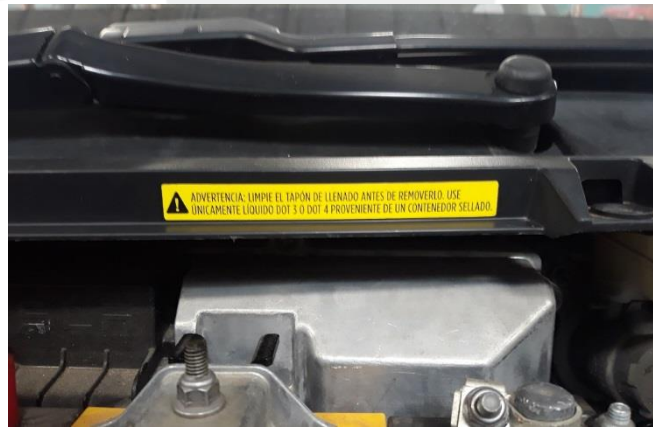
Figure 11

NOTE: Make sure that the brake fluid label is installed straight and no bubbles or deformations are present (Figure 11).

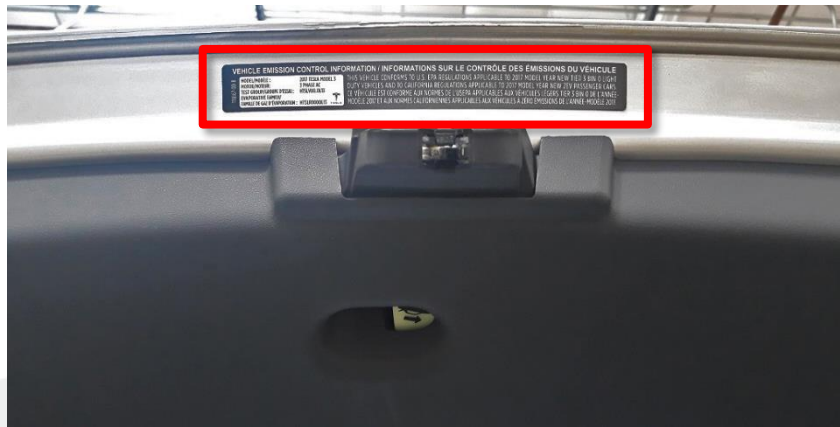
Figure 12

1. Open the trunk and locate the vehicle emission control information label near the trunk latch (Figure 12).

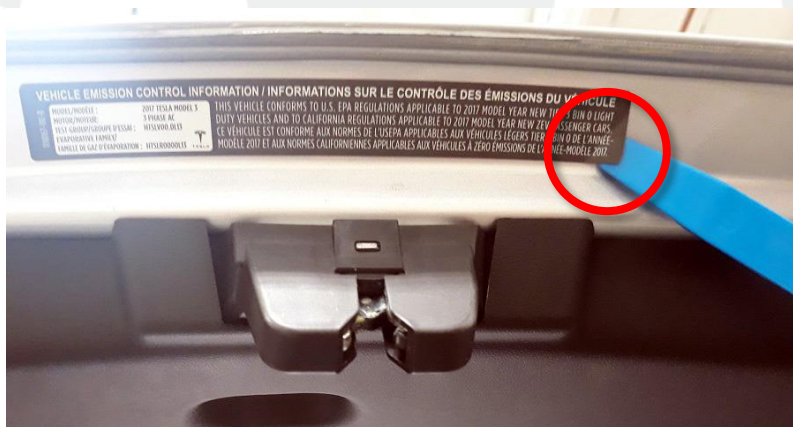
Figure 13

2. Starting from one corner, carefully peel off the label using a plastic trim tool (Figure 13).

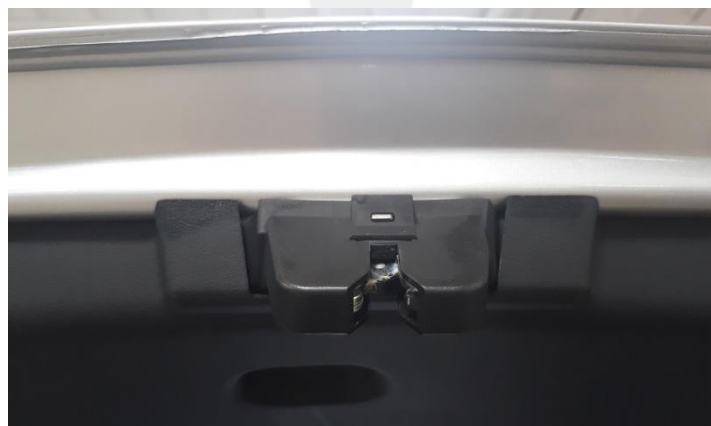
Figure 14

3. Use an IPA wipe to remove any remaining adhesive or label shreds (Figure 14).
