## V632UK, V642UK, V752UK, V852UK

### **Symptom**

Playback appears to have no head switching also VCR has no playback sound. On screen menu is in a foreign language and front buttons do not operate as they are labeled. Test switches do not operate.

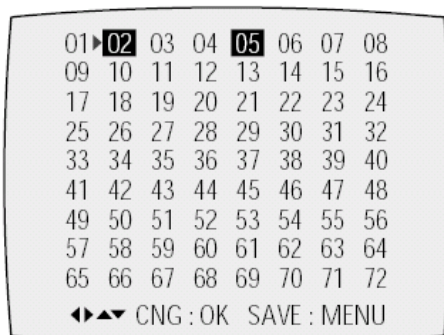
Fig. 5-14

Note: Fig 5 -14 and Fig 5 -15 are examples only, for correct settings refer to Table 5 - 2

- 1) Press the "MENU" button on the remote control about 5 seconds then option setting display is appeared.  
(See Fig. 5-14)
- 2) Select the option number (See Table 5-2) of corresponding model with "CURSOR" button on the remote control.
- 3) If selecting the option number is completed, press the "OK" button of remote control.  
(If "OK" button is pressed, the selected number is changes reversed color. ; See Fig. 5-14)
- 4) Press the "MENU" button of remote control again to store the option number.  
( "PLEASE WAIT" is displayed for a second as shown Fig. 5-15 and this setting is completed.)
- 5) Turn the Power off.
