Single-Stringer Compression Specimen for the Assessment of Damage Tolerance of Postbuckled Structures

Chiara Bisagni* and Riccardo Vescovini†

Carlos G. Dávila‡

A procedure is proposed for the assessment of the damage tolerance and collapse of stiffened composite panels using a single-stringer compression specimen. The dimensions of the specimen are determined such that the specimen's nonlinear response and collapse are representative of an equivalent multistringers panel in compression. Experimental tests are conducted on specimens with and without an embedded delamination. A shell-based finite element model with intralaminar and interlaminar damage capabilities is developed to predict the postbuckling response as well as the damage evolution from initiation to collapse.

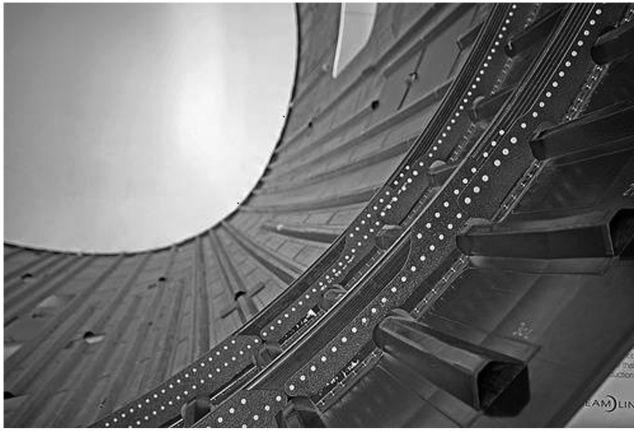
Fig. 1 Partially assembled composite fuselage section.

Aeronautical panels are stiffened with stringers in the axial direction and with frames in the circumferential direction. A typical fuselage structure is shown in Fig. 1[§], where stringers with hat section are clearly visible. The stringer configuration influences both the buckling and postbuckling behavior as well as the damage and collapse mechanisms.

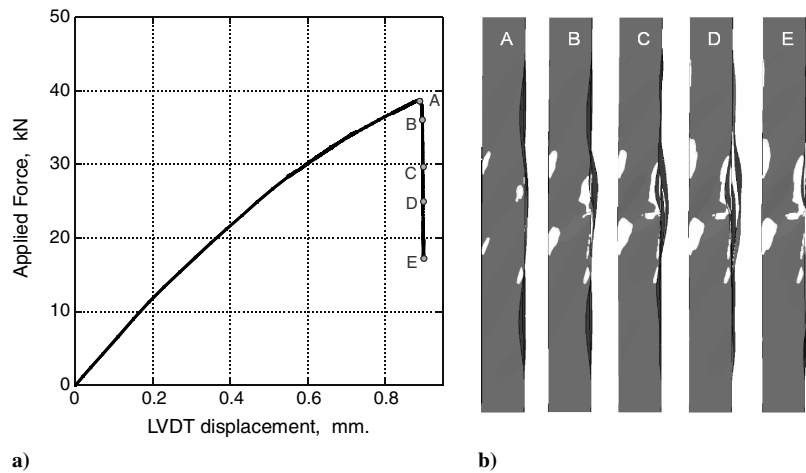
Fig. 9 Analysis of the nominally pristine specimen: a) load-displacement curve; b) skin/stringer separation (side view).

The evolution of the skin/stringer separation is shown in detail in Fig. 9. The color fringes on the edge views shown in Fig. 9b correspond to regions with fiber damage. The initiation of delamination at load point A corresponds to the peak load, and delamination propagation occurs during the collapse of the specimen. The analysis predicts a clear separation of the skin and stringer, as shown for load point E.
