AIAA 80-1260R

# Cooling of High-Pressure Rocket Thrust Chambers with Liquid Oxygen

H.G. Price\*

NASA Lewis Research Center, Cleveland, Ohio

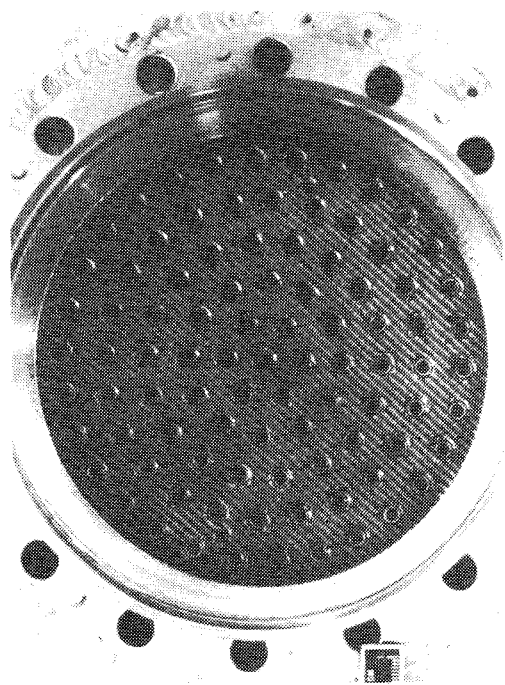
A typical faceplate view of the injectors used in this program is shown in Fig. 1. In this design, all of the hydrogen was injected through the porous metal (Rigimesh) faceplate and the oxygen was injected through 91 showerhead tubes. Two grades of porosity of Rigimesh were used: 26.9 SCMM (standard cubic meters per minute) at 0.0138 MN/m<sup>2</sup> [(950 SCFM (standard cubic feet per minute) at 2 psid)] for testing at the 4.14 MN/m<sup>2</sup> (600 psia) chamber pressure and 39.6 SCMM at 0.0138 MN/m<sup>2</sup> (1400 SCFM at 2 psid) for testing at the 8.274 MN/m<sup>2</sup> (1200 psia) chamber pressure. The diameter of the oxidizer tubes was 1.321 mm (0.052 in.) for the 4.14-MN/m<sup>2</sup> (600-psia) injectors and 1.829 mm (0.072 in.) for the 8.274-MN/m<sup>2</sup> (1200-psia) injectors.

Fig. 1 Typical face plate of experimental injector.

The 4.14-MN/m<sup>2</sup> (600-psia) injector type was used extensively on previous experimental programs<sup>7</sup> and was selected for this program because of its uniform circumferential heat flux profile, durability, and high energy release efficiency. The energy release efficiency of the injectors as measured during this program was greater than 98%.

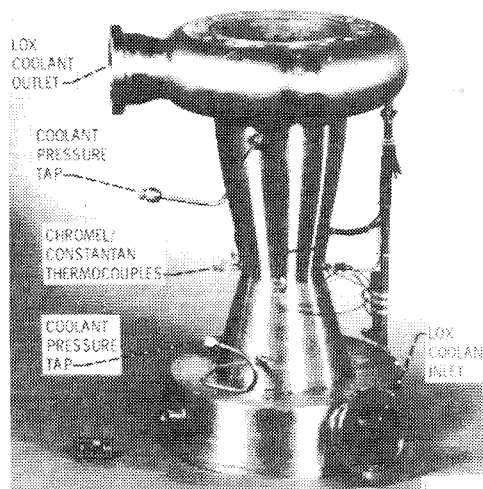
Four thrust chambers were used during this program. A photograph of a completed thrust chamber is shown in Fig. 2. The thrust chambers were instrumented with Chromel/Constantan thermocouples imbedded in the rib between coolant channels approximately 1.27 mm (0.05 in.) from the hot gas wall as described in Ref. 7. Two of the chambers, S/N 1 and 2, had four thermocouples evenly spaced circumferentially at the throat plane as shown in Fig. 2.

Fig. 2 Thrust chamber S/N 2.

The other two, S/N 3 and 4, had 16 thermocouples evenly spaced circumferentially in four axial planes, two upstream of the throat at 0.127 and 0.222 m (5 and 8.75 in.) from the injector, one at the throat 0.254 m (10 in.) from the injector, and one 0.279 m (11 in.) from the injector. Each of the chambers also had a corresponding Chromel/Constantan thermocouple attached to the outside wall in the same position as the rib thermocouple. Figure 3 shows one of the thrust chambers with four planes of instrumentation as it was installed in the test facility. The thrust chamber fired vertically downwards.

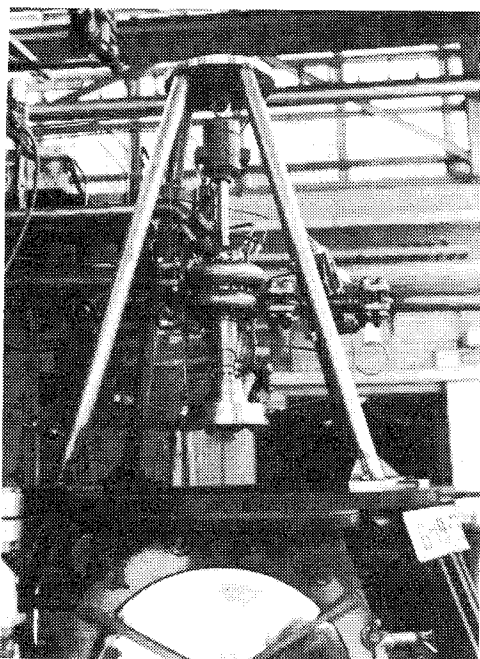
This investigation was conducted in a 222,410 N (50,000 lbf) thrust, sea-level rocket test stand equipped with an exhaust-gas muffler and scrubber. The facility used pressurized propellant storage tanks to supply the propellants to the combustion chamber. The propellants were liquid oxygen and ambient-temperature gaseous hydrogen. LOX was used as the coolant. Details of the installation can be seen in Fig. 3.

Fig. 3 Thrust chamber S/N 4 installed in test facility.

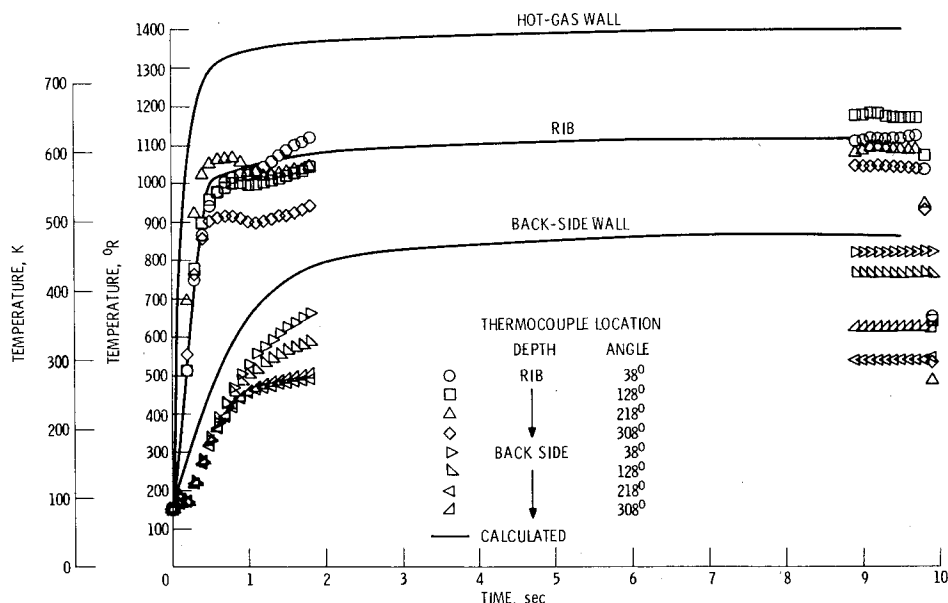
Fig. 4 Temperature histories at the throat plane chamber S/N 4:  $P_c = 4.151$  MN/m<sup>2</sup> (602 psia); O/F = 6.02.

Figure 4 is a history of the rib temperatures measured at the throat of thrust chamber S/N 4 by the thermocouples imbedded in the hot-gas wall. These thermocouples are located within 1.27 mm (0.05 in.) of the combustion surface. The operating conditions of this test were  $4.151 \text{ MN/m}^2$  (602 psia) chamber pressure and a mixture ratio of 6.02. Also included in this figure are the outer or back-side wall temperature as measured by the thermocouples attached to that surface.

The SINDA computer program<sup>8</sup> using a cross-sectional model of the coolant channel, was used to predict 1) the hot-gas wall temperature, 2) the rib temperature, and 3) the outer or back-side wall temperature.

These temperatures are also plotted in Fig. 4. The predicted temperatures were based on the hot-gas heat transfer correlation as obtained previously<sup>7,9</sup> with hydrogen/oxygen propellants in this size thrust chamber and the same type of injector. The coolant-side heat transfer coefficient was obtained from the supercritical liquid oxygen correlation as described in the section "Heat Transfer Correlation." From the plot it can be seen that the temperature predictions followed the measured temperatures very closely at the rib temperature location. The back-side predicted wall temperature was higher than any of the measured temperatures. This is probably due mostly to axial heat transfer effects and some convective heat loss to the surroundings which are not accounted for by the computer model.

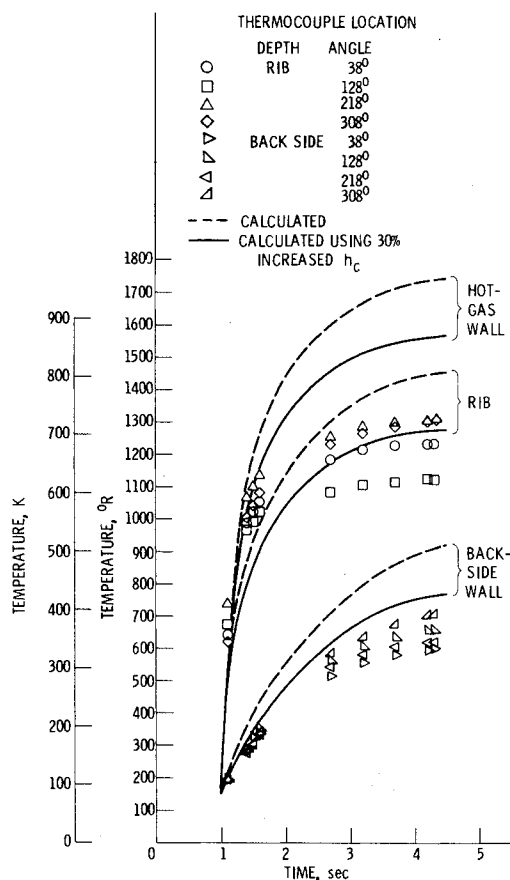
Figure 5 is a histogram of measured rib and back-side temperatures also in the throat plane except in this case the thrust chamber was S/N 2 and the operating conditions were

$8.067 \text{ MN/m}^2$  (1170 psia) chamber pressure and a mixture ratio of 4. For this test it was necessary to increase the coolant-side heat transfer coefficient by 30% to obtain agreement between the predicted rib temperature and the measured rib temperature. Both the original predicted temperatures and the temperatures obtained by increasing the coefficient by 30% are plotted. This increase is within the data scatter band of the original heat transfer correlation development.

Fig. 5 Temperature histories at the throat plane chamber S/N 2:  $P_c = 8.067 \text{ MN/m}^2$  (1170 psia); O/F = 4.

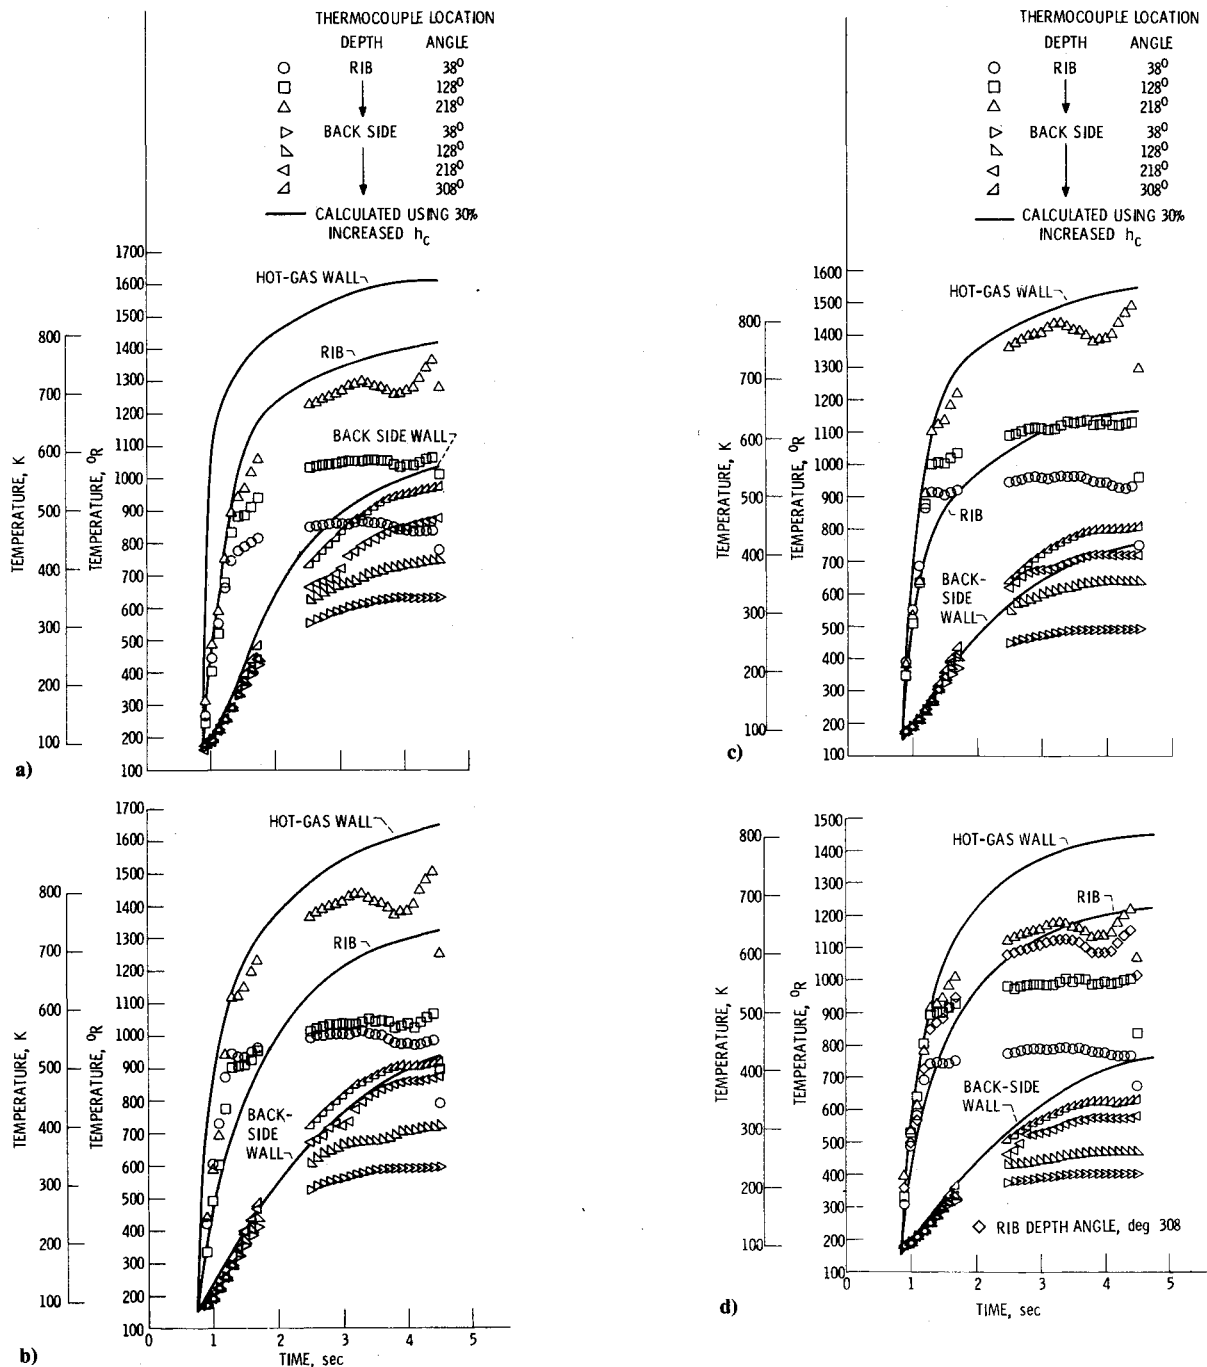
Figures 6a-d are histograms obtained at the four instrumented planes with thrust chamber S/N 3. The operating conditions were  $8.315 \text{ MN/m}^2$  (1206 psia) chamber pressure and a mixture ratio of 4.1. In Fig. 6 data are presented at planes of 0.127 m (5 in.), Fig. 6a; 0.222 m (8.75 in.), Fig. 6b; 0.254 m (10 in.), Fig. 6c; and 0.279 m (11 in.), Fig. 6d from the injector. Examination of the figures shows a large amount of circumferential variation in wall temperatures. This resulted from a slightly damaged injector which produced some high-temperature combustion gas streaks. Again the predicted temperatures of Fig. 6 were obtained with a coolant-side heat transfer coefficient which was increased by 30%. Because of the large amount of scatter in the experimental data, it is impossible to draw any conclusions on the agreement between experimental and predicted results. In general, the experimental data scattered around the predicted rib temperature with a 30% increase in the coolant-side heat transfer coefficient.

Fig. 6 Temperature histories: a) 0.127 m (5 in.) from injector chamber S/N 3;  $P_c = 8.315 \text{ MN/m}^2$  (1206 psia); O/F = 4.1. b) 0.222 m (8.75 in.) from injector chamber S/N 3;  $P_c = 8.315 \text{ MN/m}^2$  (1206 psia); O/F = 4.1. c) 0.254 (10 in.) from injector (throat) chamber S/N 3;  $P_c = 8.315 \text{ MN/m}^2$  (1206 psia); O/F = 4.1. d) 0.279 m (11 in.) from injector chamber S/N 3;  $P_c = 8.315 \text{ MN/m}^2$  (1206 psia); O/F = 4.1.

With this limited amount of data of  $4.14 \text{ MN/m}^2$  (600 psia) and  $8.274 \text{ MN/m}^2$  (1200 psia) chamber pressure, it is not known if the trend of 30% increase to the coolant-side heat transfer coefficient at  $8.274 \text{ MN/m}^2$  (1200 psia) will continue as chamber pressure increases. It is therefore recommended that the supercritical liquid oxygen correlation be used in its original form. This would give a conservative design until more data at the higher pressures can be obtained.

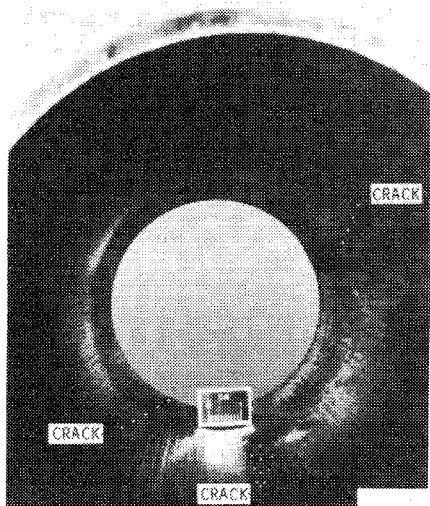
which was operated 23 cycles after a crack (leakage) was evident. Figure 7 shows a number of the cracks in the chamber wall. Chambers S/N 1 and 4 were also operated a few cycles after a crack was formed in the chamber wall. None of these chambers showed any signs of apparent metal burning or distress. The cracks acted like the cracks that developed when hydrogen was used as the coolant. There were no catastrophic failures during the test program.

Fig. 7 Inside wall surface of thrust chamber S/N 2 after 176 hot fire cyclic tests.

5) The thrust chamber wall cracks that formed as a result of the cyclic testing with LOX as the coolant appeared to have similar characteristics to those with liquid hydrogen as the coolant.
