Advanced Composite Materials

Influence of water saturation on fracture toughness in woven natural fiber reinforced composites

Abstract—Woven sisal textile fiber reinforced composites were used to evaluate fracture toughness, tensile and three-point bending. The water absorption testing of all specimens was repeated five times in this study. All specimens were immersed in pure water during 9 days at room temperature, and dried in 1 day at 50°C. Two kinds of polymer matrices such as epoxy and vinyl-ester were used. Fractured surfaces were taken to study the failure mechanism and fiber/matrix interfacial adhesion. It is shown that it can be enhanced to improve their mechanical performance to reveal the relationship between fracture toughness and water absorption fatigue according to different polymer matrices. Water uptake of the epoxy composites was found to increase with cycle times. Mechanical properties are dramatically affected by the water absorption cycles. Water-absorbed samples showed poor mechanical properties, such as lower values of maximum strength and extreme elongation. The K_{IC} values demonstrated a decrease in inclination with increasing cyclic times of wetting an

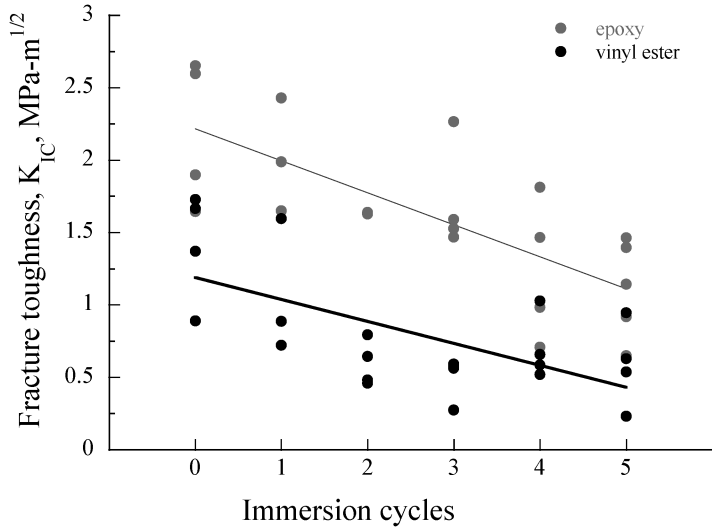
Figure 7. Distribution of critical stress intensity according to immersed cyclic times.

The critical stress intensity factor in mode I fracture (K_{IC}) as a function of the wetting and drying cycle times is shown in Fig. 6 for the epoxy and vinyl-ester. Here, K_Q values were calculated according to ASTM D 5045-96 as shown in equations (1) and (2).

The K_{IC} values demonstrate a decrease in inclination with increasing cyclic times of wetting and drying for the epoxy and vinyl-ester. Two curves of the average K_{IC} values show the parallelism with each other in a downward direction with the increase of cyclic times as shown in Fig. 7. The effect of crack orientation on K_{IC} values is not clear. The K_{IC} values of the epoxy and vinyl-ester ranged from

0.64 to 2.66 MPa m^{1/2} and from 0.22 to 1.75 MPa m^{1/2}, respectively, in the cyclic composites.
