FIGS. 7-12. Oscillograph records of induction coil spark discharges. FIG. 7, taken with a suitable air-dielectric capacity shunting the spark gap; FIG. 8, complete discharge; FIG. 9, late cut-off of discharge; FIG. 10, cut-off at  $T_3$ ; FIG. 11, cut-off at  $T_2$ ; FIG. 12, cut-off at  $T_1$ .

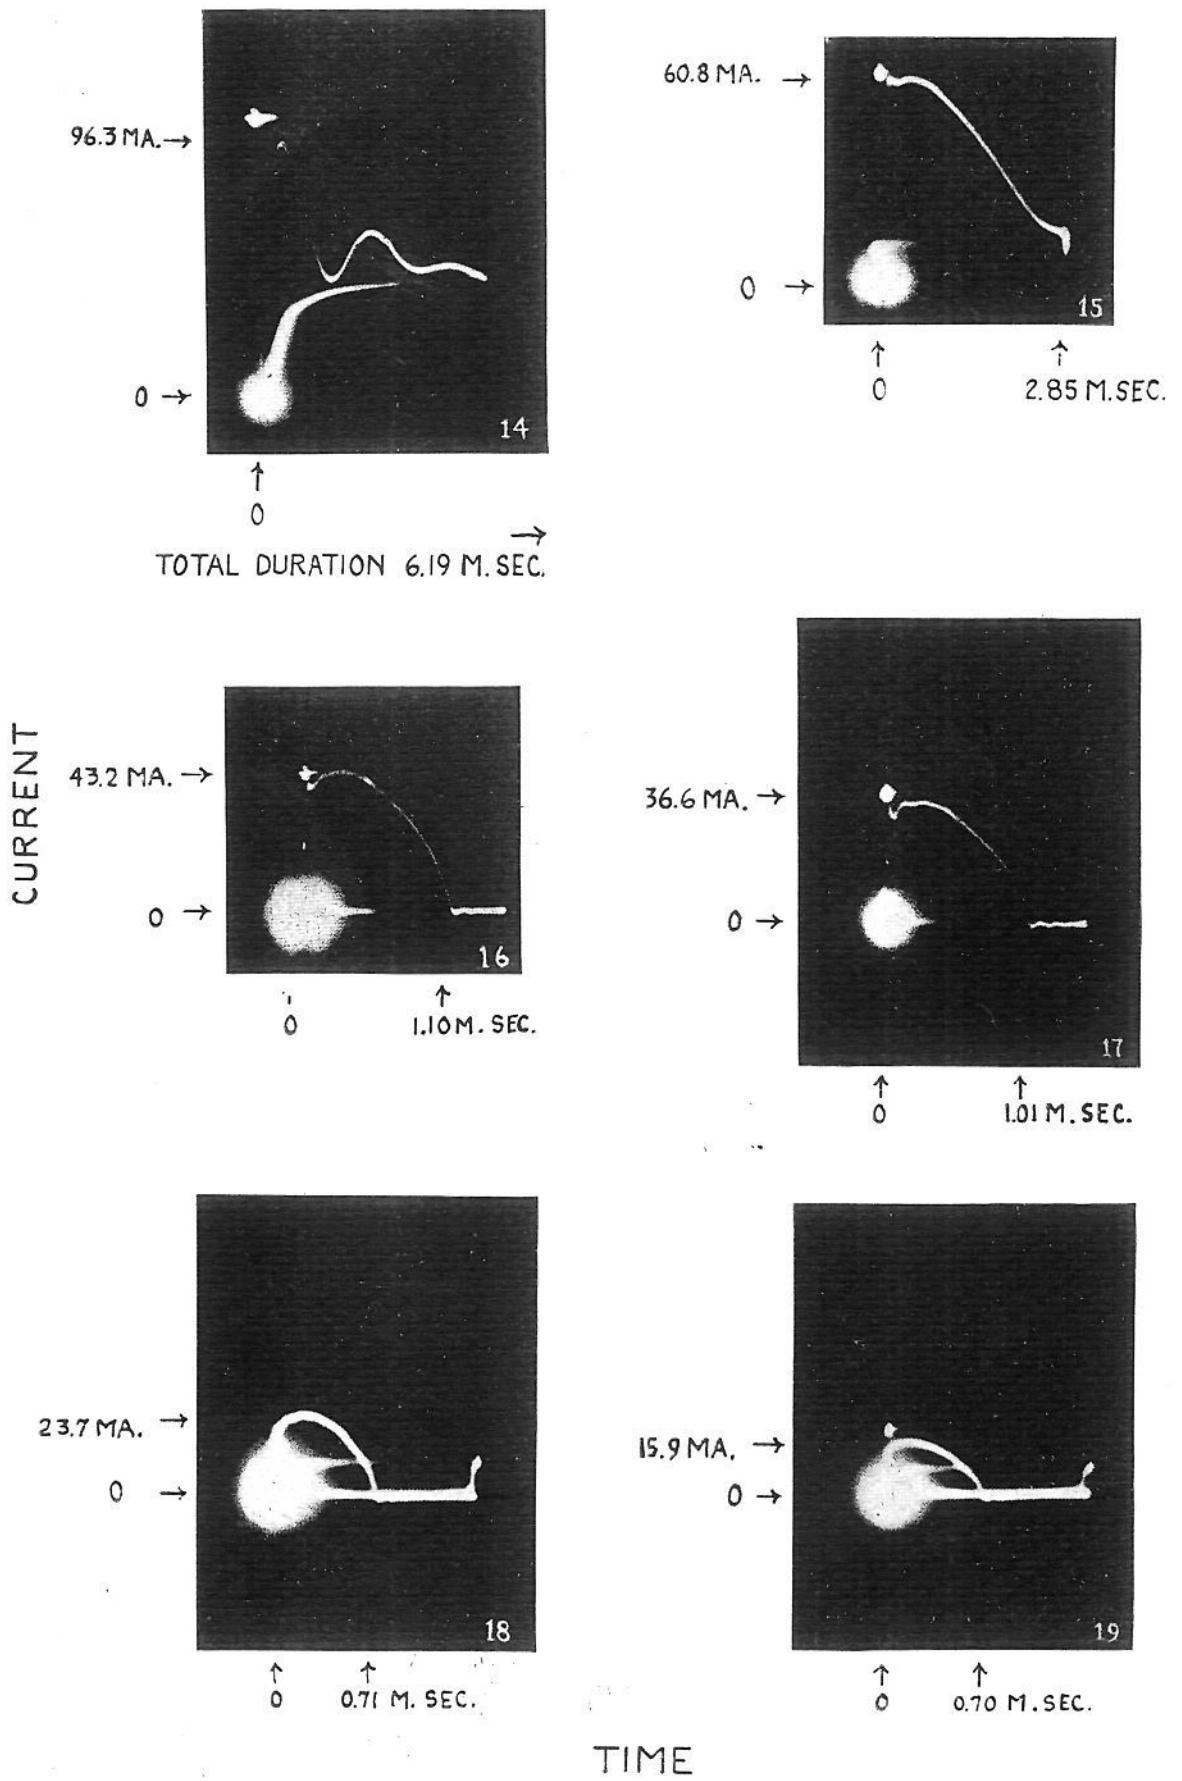
FIGS. 14-19. Oscillograph records of induction coil spark discharges
