Enamel loss and adhesive remnants following bracket removal and various clean-up procedures *in vitro*

Sacha Ryf*, Simon Flury**, Senthamaraiselvi Palaniappan***, Adrian Lussi**,
Bart van Meerbeek*** and Brigitte Zimmerli**,***

SUMMARY This study evaluated the enamel loss and composite remnants after debonding and clean-up. The tested null hypothesis is that there are no differences between different polishing systems regarding removing composite remnants without damaging the tooth surface. Brackets were bonded to 75 extracted human molars and removed after a storage period of 100 hours. The adhesive remnant index (ARI) was evaluated. The clean-up was carried out with five different procedures: 1. carbide bur; 2. carbide bur and Brownie and Greenie silicone polishers; 3. carbide bur and Astropol polishers; 4. carbide bur and Renew polishers; and 5. carbide bur, Brownie, Greenie and PoGo polishers. Silicone impressions were made at baseline (T0) and after debonding (T1) and polishing (T2) to produce plaster replicas. The replicas were analysed with a three-dimensional laser scanner and measured with analytical software. Statistical analysis was performed with the Kruskal–Wallis te

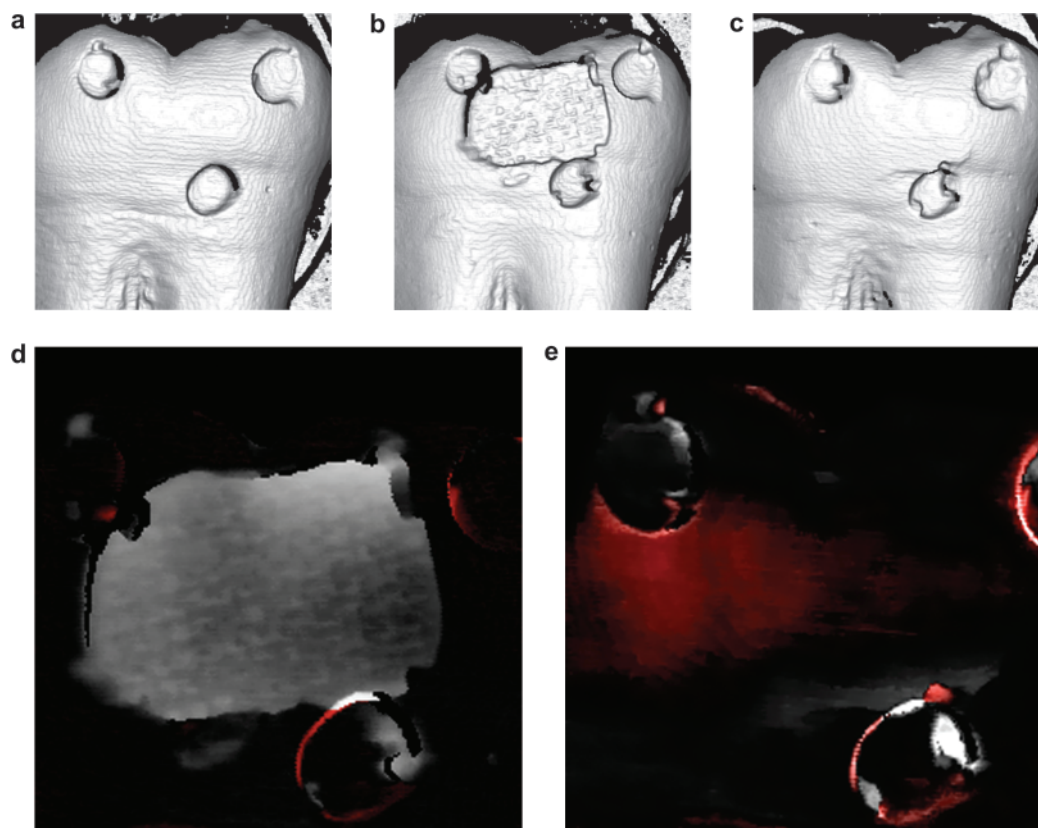
Figure 1 Images at baseline (T0). (a), after bracket removal (T1) (b) with a clearly visible resin remnant, after clean-up (c) and differences after overlapping baseline T0 and T1 (d). Resin remnant is shown (white) and (e) T0 and T2. Loss of surface substance (red) and resin remnants (white) are visible.

Silicone impressions (President microSystem light/regular body; Coltène/Whaledent AG, Altstätten, Switzerland) were taken of the buccal surfaces of the teeth. Baseline models (T0) were produced in dental stone (Fuji Super Hardrock, GC, Leuven, Belgium) and scanned with the 3D imaging device (Laserscan 3-D Pro; Willytec GmbH, Gräfelfingen, Germany) to establish T0 data (Figure 1a).

The brackets were debonded by gently squeezing with Weingart pliers (3M Unitek). A second impression was taken of the buccal surfaces of the teeth after debonding (T1), and replicas were made in dental stone (Figure 1b).

A third impression (T2) was then taken of the surface of every tooth (Figure 1c).

By matching T1 to T0, the height and volume of composite remnant was recorded (Figure 1d). If present, enamel defects were recorded in terms of depth of lesion and volume loss. Therefore, the areas of interest analysed from the differential image were selected and separately measured. Comparing the T2 with the T0 models, vertical and volumetric changes in surface geometry were measured (Figure 1e). However, enamel breakouts that were recorded by superimposing T1 on T0 were always at the margin of the area of interest and excluded from further surface analysis. If defined, composite remnants were left, and the height and volume of the remnants were separately recorded.

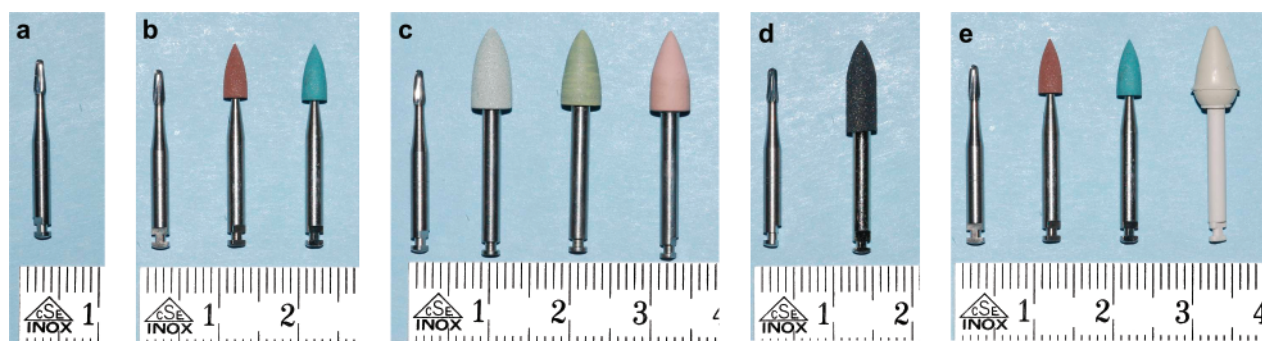
Figure 2 (a) Group 1 (carbide bur). (b) Group 2 (carbide bur, Shofu Brownie and Shofu Greenie). (c) Group 3 (carbide bur, Astropol polishing system: F, P, and HP). (d) Group 4 (carbide bur, Renew System). (e) Group 5 (carbide bur, Shofu Brownie, Shofu Greenie, and PoGo polisher).

The residual adhesive on each tooth in the five groups was removed using one of the five following protocols: group 1, carbide bur (Figure 2a); group 2, carbide bur followed by Brownies and Greenies (Figure 2b); group 3, carbide bur followed by Astropol F, P, and HP polishers (Figure 2c); group 4, carbide bur followed by the Renew System (Figure 2d); and group 5, carbide bur followed by Brownies and Greenies and finished with a PoGo polisher (Figure 2e).

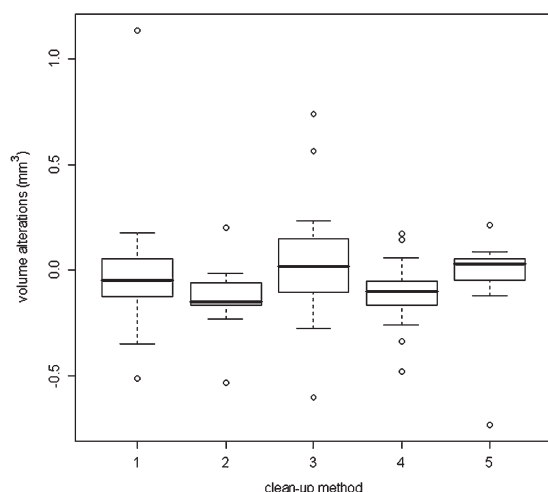
Figure 3 Box-and-whisker plot showing median, first and third quartiles, and minimum and maximum values. Circles denote outliers in volume alterations after clean-up with five different methods. Groups as listed in Table 2.

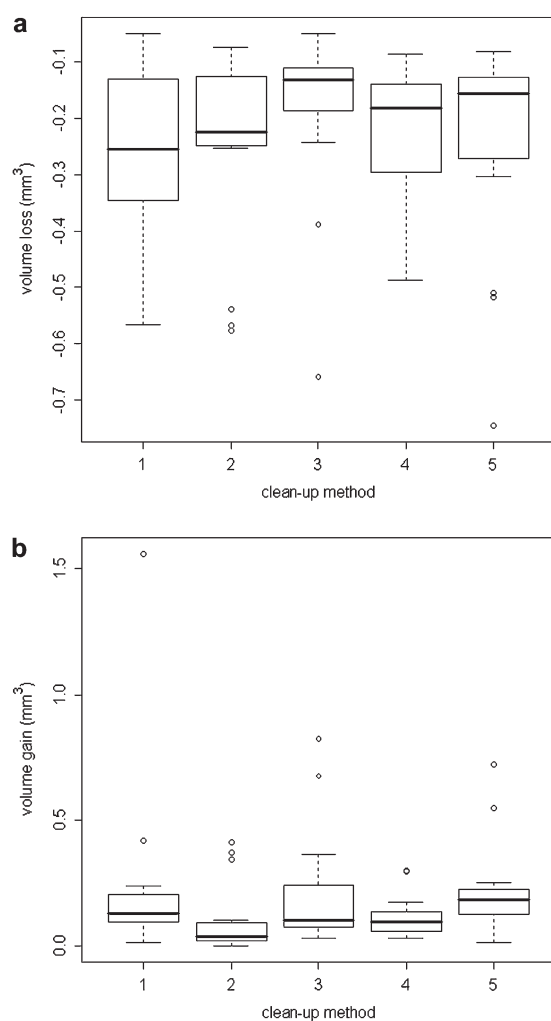
Figure 4 Loss of volume (a) and composite remnants (b) after clean-up with five different methods. Groups as listed in Table 2.

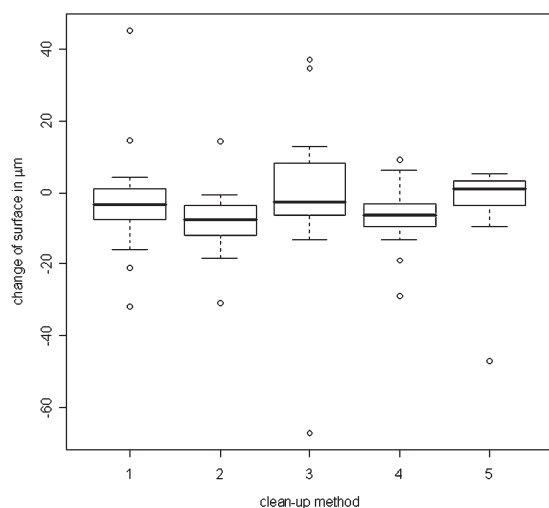
Figure 5 Surface alteration after clean-up with five different methods. Groups as listed in Table 2.

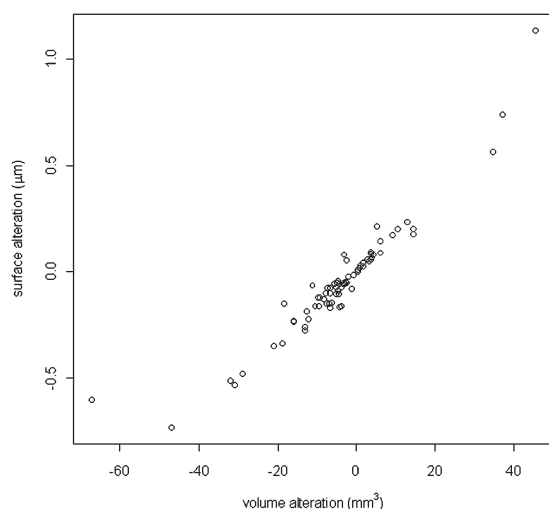
Figure 6 Correlation of linear versus volumetric surface changes. Spearman rank correlation coefficient = 0.95.

other groups showed no significant differences, although the difference between groups 4 and 5 was almost significant ($P = 0.04$; but not significant due to Bonferroni correction). Comparisons of the variances of the different clean-up procedures' total volume loss and composite remnants showed that there were differences, although not significant, between the groups (Figure 4a and 4b). The least aggressive method for enamel, with minor removal of hard dental substance, was found in group 3. The method in group 1 seemed to be more aggressive. However, all methods left some remaining composite on the tooth surface, with group 5 leaving the most. Spearman correlation showed a clear linear correlation of volume alteration to linear surface alterations (correlation coefficient: 0.95; Figure 6).
