DURABILITY OF STIFFENED COMPOSITE PANELS UNDER REPEATED BUCKLING

TANCHUM WELLER and JOSEF SINGER

Faculty of Aerospace Engineering, Technion—Israel Institute of Technology, Haifa 32000, Israel

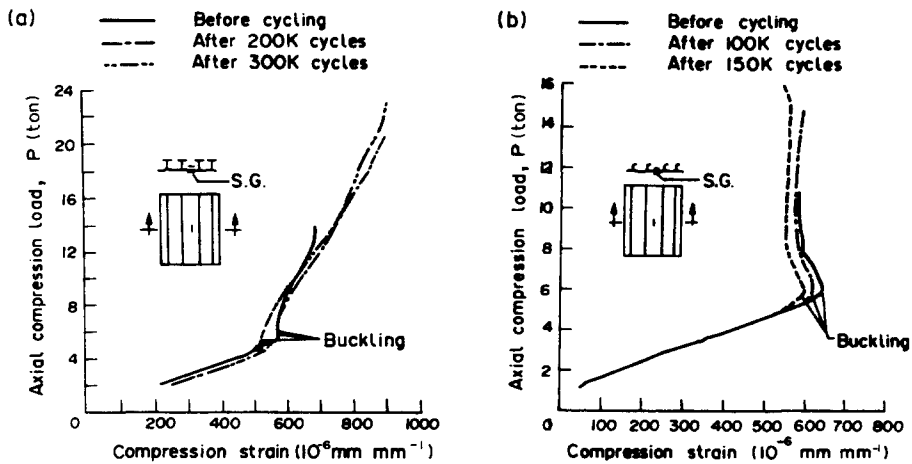
Fig. 19. Axial compression strains in center of skin. (a) Panel J2. Membrane strains at midspan in the skin of panel 2. (b) Panel J6. Membrane strains in central bay at mid-span panel 6.

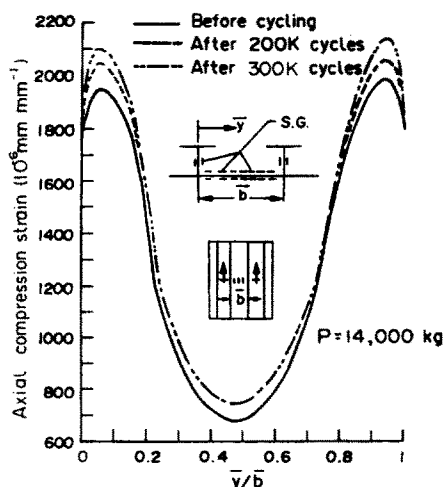
Fig. 20. Influence of repeated buckling on the axial compression in panel I2 (P in tons). Cyclic loading effects on membrane strains distribution of skin in panel 2.
