## Rare cause of light failure in two Macintosh blades within 2 weeks

To the Editor:

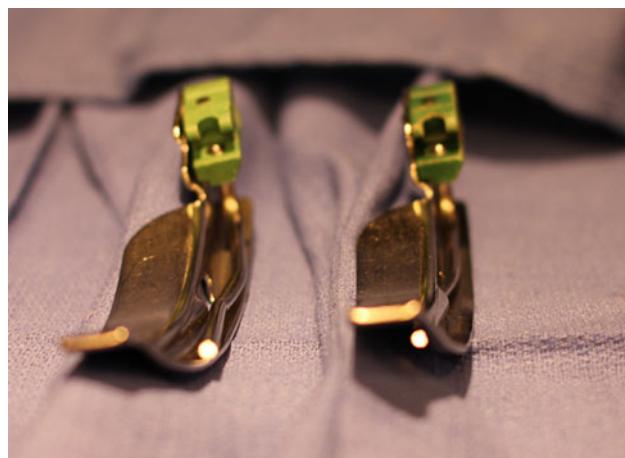
Further analysis of the Macintosh blades revealed that the fiberoptic light guide had been misplaced on the wrong side of the flange (Fig. 1). Upon questioning of the anesthesia technician, it was noted that the individual frequently removes the fiberoptic channel for cleaning purposes and screwed the fiberoptic bundles back on the blade incorrectly. The fiberoptic bundles were not passed through the sidewall to the right side of the blade. The light source was misplaced on the left side of the flange, which is used to sweep the tongue to the left during direct laryngoscopy. Therefore, the light only shone onto the patient's tongue and did not illuminate the airway.

**Fig. 1** Laryngoscope blade showing incorrect light source placement (*left*) and correct light source placement (*right*)

A thorough analysis of all laryngoscopes needs to be performed before use. It was also beneficial to have an additional laryngoscope blade and handle available if failure were to occur.
