A Range of Postmortem Assault Experiments Conducted on a Variety of Denture Labels Used for the Purpose of Identification of Edentulous Individuals

ABSTRACT: Forensic organizations worldwide have recommended that dental prostheses should be labeled with at least the patient's name and preferably with further unique identifiers such as social security number, etc. The practice of denture marking has been conducted over many years and several denture marking systems have been reported in the dental literature. However, very little is known about the resilience of such systems to conditions experienced in the majority of post- and perimortem assaults. The purpose of this investigation therefore, was to expose a selection of 10 denture labels to a series of hostile environments. Results of the study indicate that the majority of the denture labeling systems appear capable of withstanding a range of common, and not so common postmortem assaults. With regard to thermal insult, however, most performed badly with the exception of a label constructed from stainless steel orthodontic band. However, another label in the form of an electronic RFID-tag performed above expectations in the major

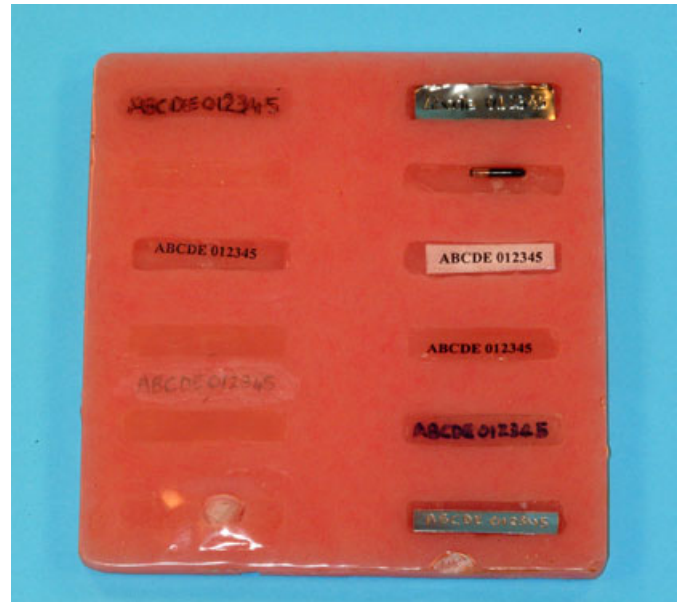
A 10 × 10 × 0.5 cm block was manufactured from polymethylmethacrylate acrylic (PMMA) pink/veined denture base resin. One example each of the following denture identification labels was then placed into the block to a depth of 2 mm before being covered by clear self-cure PMMA (Fig. 1).

FIG. 1—A 10 × 10 × 0.5 cm block manufactured from polymethylmethacrylate acrylic (PMMA) pink/veined denture base resin. One example of each denture identification label was placed into the block to a depth of 2 mm before being covered by clear self-cure PMMA.

Position 1 (top left) shows an example that involves cutting a groove of *c.* 0.5 to 1 mm deep into the buccal flange of the denture, the length of which would correspond to the length of the patient's name. An ordinary ballpoint pen or felt-tip pen is then used to print the patient's name in the recess before being sealed with fissure sealant.

Position 2 (below) shows a technique in which the patient's name is typed on a piece of "onion skin" paper and incorporated within the fitting surface of the denture during the packing procedure.

Position 3 shows an example that allows the dentist to write on the surface of the denture using a spirit-based pen or pencil prior to covering the ID mark with a clear denture base polymer dissolved in chloroform.

Position 4 (bottom left), utilizes a standard soft metal band that is either typed or engraved with the patient's details before being rolled up and inserted into a predrilled cavity *c.* 2–3 mm wide. A

small wax plug is then placed over the metal band prior to filling the remainder of the cavity with self-cure resin.

Position 5 (top right) is a method involving the use of a typed, commercially produced metal strip (trade name: ID-Band) embedded into the polished surface of the denture and covered with clear acrylic.

Position 6 houses an RFID system consisting of a data carrier, generally known as a tag or transponder. The tag consists of a torpedo-shaped microchip with a coiled antenna, measuring 8.5 mm × 2.2 mm. The transponder may be embedded into either the polished or fitting surface of an existing denture.

Position 7 includes an example similar to that of an ID label that had been produced in a 'P-touch' electronic lettering system (P-touch, Brother Co., Canada). The label used consisted of a 103 μm thick, white or clear laminated strip onto which 2 mm characters are typed, after which it is incorporated into the denture subsequent to its fabrication.

Position 8 is made from a label printed on 35 mm photographic slides via the use of a computer graphics package. The label is embedded into the denture base and covered with clear acrylic.

Position 9 shows an example in which a fine fiber-tipped pen was used to mark a label made from a partially polymerized strip of PMMA before including in the fitting surface of the denture base during the trial packing procedure.

Position 10 (bottom right) utilizes a piece of 0.125 mm thick stainless steel orthodontic tape onto which the patient's details are engraved. The tape is then incorporated into the fitting surface of the denture during the trial packing stage.

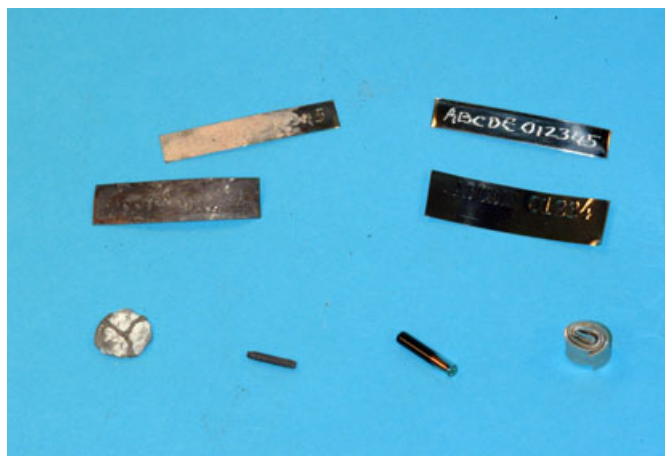
FIG. 2—Remains of the fire experiment, i.e., the stainless steel orthodontic band, the ID-Band, the soft metal foil, and the remains of the RFID-tag. Featured on the right are the intact versions of the labels.

Test 4 involved setting the specimen on fire. The specimen block was then extinguished after 5 min in order to test the function of the RFID-tag. The tag responded normally to the reader. The specimen block was reignited and allowed to burn for a further 5 min. However, when tested a second time, the tag failed to respond. The specimen block was again reignited and left to burn until all of the PMMA was consumed. Fig. 2 shows the results of the experiment, i.e., all that remained of the specimens were specimens number 5, the ID-band and number 10, the stainless steel orthodontic band. Other debris identified were the remains of specimen number 4, the soft metal band that had been rolled into a coil. All that remained of the RFID-tag was the graphite rod on which the copper coil antenna was positioned.

Test 5, in which the specimens were placed into a crematorium yielded similar results to that of test 4.

marking method possesses the ability to withstand a range of chemical and thermal insults. The stainless steel orthodontic band was by far the most impressive denture label tested in that it outperformed the commercially produced ID-Band which purports to be able to withstand temperatures c. 3000°C. However, is such a property really necessary? With respect to thermal insult, Thomas et al. (12) reported that a denture which remains in the mouth during incineration is very well protected by the surrounding soft tissues (14) and that at least the posterior half to one-third will remain intact. Hence any mark which is present, even one which is not fire resistant, has been proven empirically to survive incineration. However, Ling argued that if a denture is expelled from the mouth (as often happens in violent accidents such as air crashes), and there is a fire, the denture may be destroyed, but its fire resistant marker would remain intact, ready for retrieval (15). Thomas, on the other hand, disagreed with this statement and questioned whether, if found, would such a label be readable or indeed when commingled with the other debris would it indeed be recognized as a denture label (8)? Hence for the aforementioned reasons they concluded that to incorporate a fire resistant denture label would probably be a futile exercise.
