Interaction of metals and alloys with silicon-based ceramics

R. L. MEHAN, D. W. MCKEE

Physical Chemistry Laboratory, General Electric Company, Schenectady, New York, USA

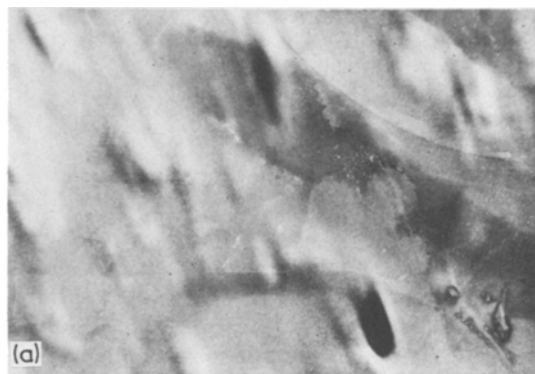
Figure 14 Electron probe photographs of SiC/IN-718 reaction zone, showing (a) specimen current image, (b) Ti X-ray image, and (c) Nb X-ray image.

noted in this region. Microprobe analysis indicated that the needles and the irregular particles in the alloy were rich in Ti and Nb, as shown in the X-ray maps in Figs. 14a, b and c. The concentrations of Si and oxygen were low in these phases, which were assumed to be carbides. Increased concentrations of Si and Cr were found in the matrix between the acicular particles, although discrete silicide particles were not identified.
