CASE REPORT Use of SPEED Supercable with Sectional Mechanics

This article describes such a case that was resolved by the use of a sectional SPEED appliance with a SPEED Supercable archwire.

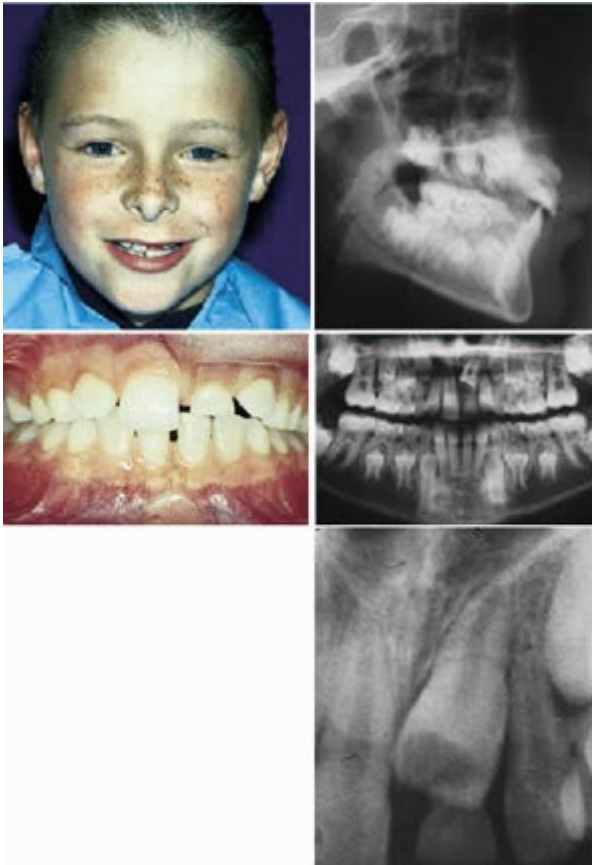
Fig. 1 10-year-old male with retained maxillary left deciduous central incisor. Note angulation of maxillary lateral incisors.

Placement of a full fixed appliance may not be feasible in the early mixed dentition because of a lack of teeth available for bonding. There is also a risk of root resorption if the lateral incisors are bonded when the incisor roots are in close proximity to the crown of the developing permanent canine (Fig. 1).

A 10-year-old boy presented with a retained maxillary left deciduous central incisor associated with failure of eruption of the permanent successor (Fig. 1). Both maxillary lateral incisors and the right central incisor had erupted. The unerupted permanent incisor was palpable high in the buccal sulcus. Radiographs confirmed the clinical findings and ruled out the possibility of a midline supernumerary.

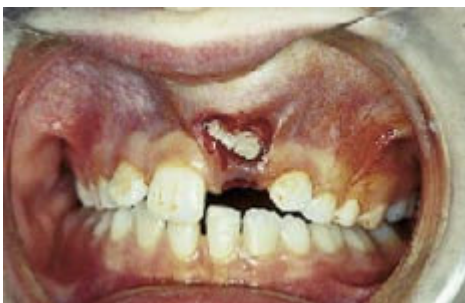
Fig. 2 After exposure of maxillary central incisor.

Initial treatment involved the removal of the retained deciduous incisor and exposure of the maxillary left central incisor (Fig. 2). Four months after the surgery, some spontaneous eruption of the permanent incisor had occurred, but it was evident that orthodontic intervention would be required to bring the tooth into the arch (Fig. 3). SPEED brackets were placed on the two central incisors, and an .016" Supercable archwire was engaged in the brackets. Light-cured composite stops were added to the archwire to prevent archwire disengagement or fraying of the wire ends (Fig. 4).

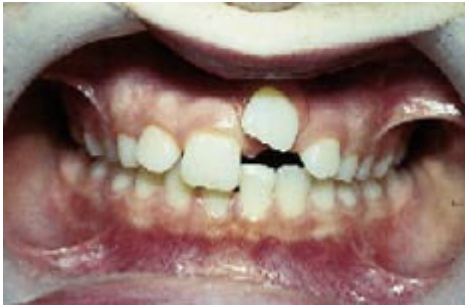
Fig. 3 Four months after exposure.

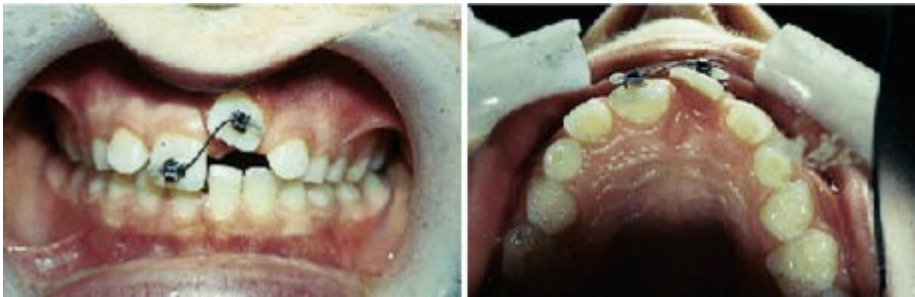
Fig. 4 Sectional SPEED appliance with Supercable wire. Note composite stops to prevent fraying of wire ends.

SPEED Supercable is a superelastic nickel titanium coaxial wire consisting of seven interwoven strands. The superelastic properties of Supercable allow full bracket engagement with extremely low unloading force delivery. In this case, full ligation of any other wire might have resulted in permanent deformation of the archwire, debonding of the brackets, or application of excessive force.

Supercable is designed to accept sharp bends without taking a permanent set. Therefore, distal end bends are impossible. Although light-cured composite stops were used in this case, specially designed Supercable stops are also available.

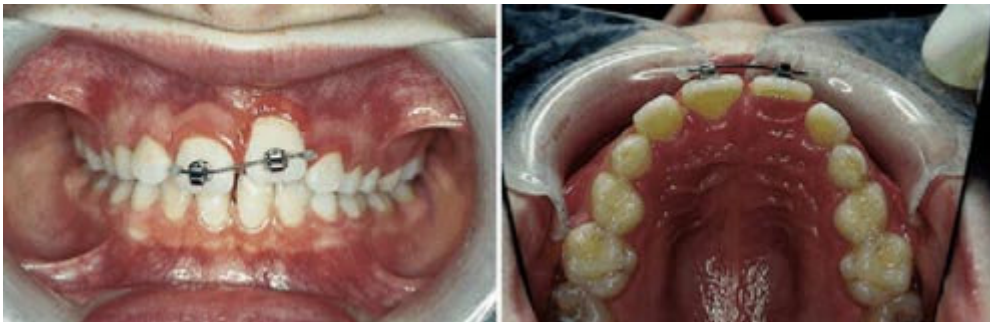
Fig. 5 After eight weeks of treatment with sectional SPEED appliance.

A marked improvement in tooth position was evident eight weeks later (Fig. 5). The appliance was removed after six months of active treatment (Fig. 6), and the final radiograph showed good tooth alignment with no evidence of root damage. A bonded palatal retainer was placed to counteract any vertical or rotational relapse tendency (Fig. 7).

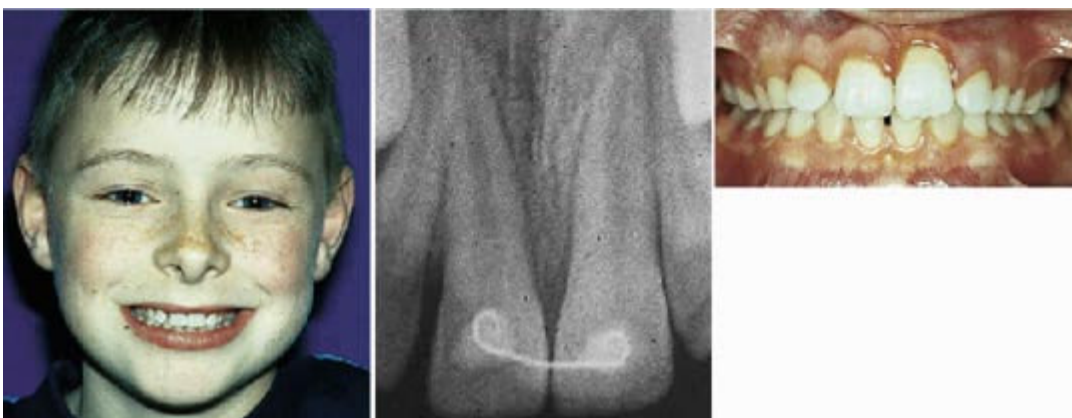
Fig. 6 After six months of active treatment.

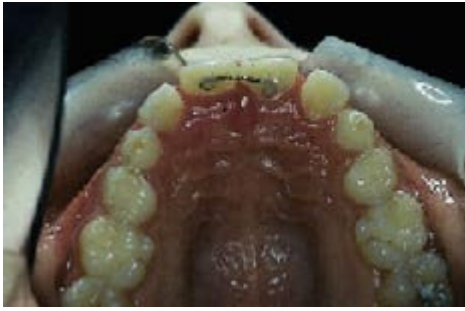
Fig. 7 Bonded palatal retainer.
