Performance of V–4Cr–4Ti material exposed to the DIII-D tokamak environment

H. Tsai ^{a,*}, W.R. Johnson ^b, Y. Yan ^a, P.W. Trester ^b, A. Bozek ^b, J.F. King ^c,
D.L. Smith ^a

Abstract

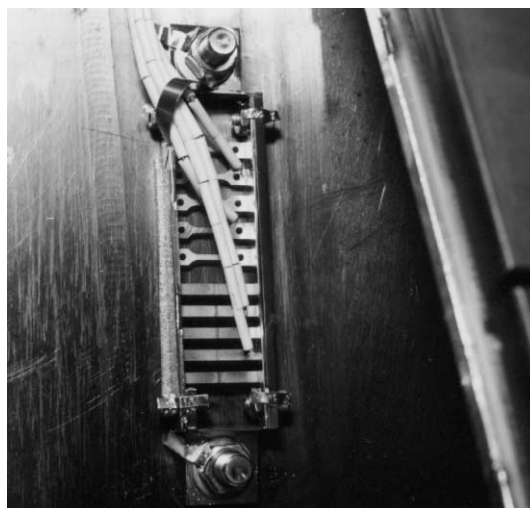
Fig. 2. Mounting of the W2 specimens in bracket on DIII-D vessel wall.

Each of the W1, W2 and B1 tests consisted of a number of miniature Charpy impact and tensile specimens held in a frame mounted on the vessel wall. The W1 and W2 tests were mounted behind a lower divertor baffle whereas the B1 test was mounted behind the inner section of the upper radiative divertor (upper private flux baffle). The temperatures of the specimens were measured with thermocouples attached to the ends of the specimens. Fig. 2 shows the mounting of the W2 test.
