# DEFENSE TECHNICAL INFORMATION CENTER

Data contained in this report were taken from two sources: the official reporting media and personal interviews with participants. Past WSEG experience in collecting combat data<sup>1,2</sup> has shown that the official reporting media, which are designed primarily for military operational and statistical needs, are inadequate for many analytic purposes. The project groups conducting these earlier studies found that personal interviews with participants were necessary for R&D analyses. In Project RED BARON, interviews were considered the primary data source, supplemented, where available, by official reports.

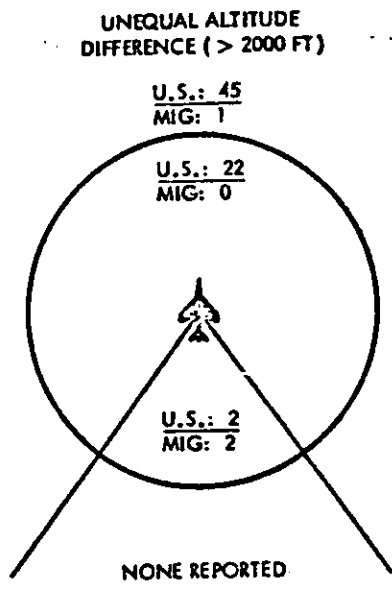
FIGURE III-B2 (S). Ratio of U.S. to MIG-17 First Firings for Different Acquisition Conditions (U)

- The relative frequency of attaining a first firing position when the enemy is not detected until positioned in the rear quadrant.
- The effectiveness of the enemy's weapon system in utilizing the first firing opportunity.
