# GERMAN LIGHT PANZERS 1932-42

VANGUARD SERIES

BRYAN PERRETT

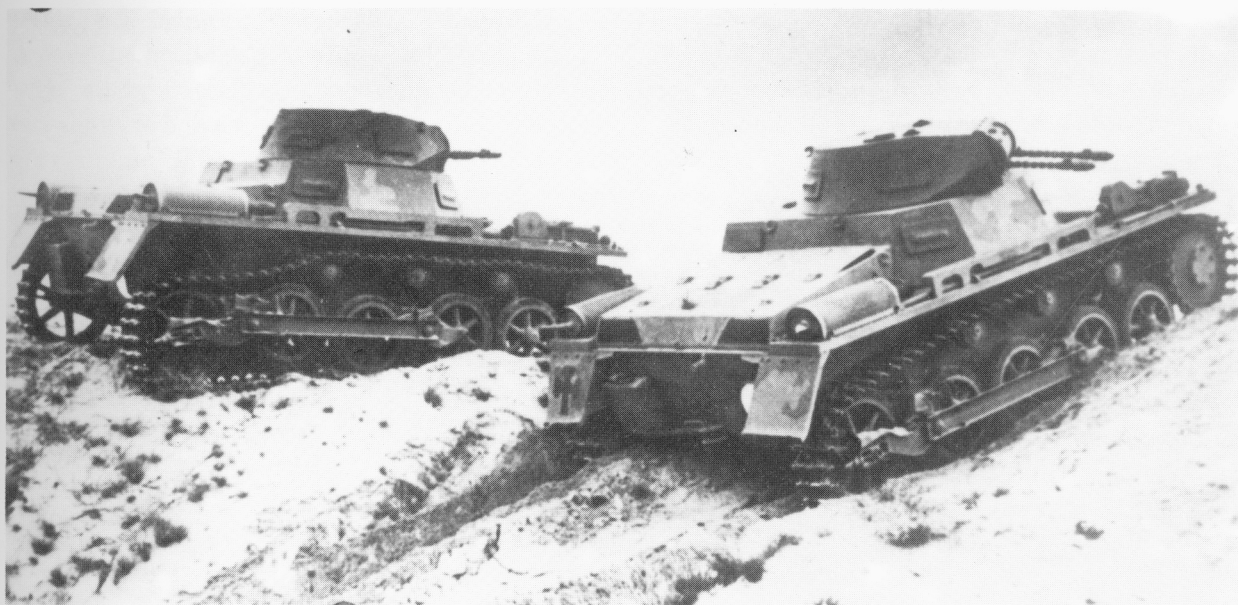
**PzKpfw I Ausf. A tanks manoeuvre during a training exercise, probably in summer 1935 at Munster Lager. A hard-edged pattern, probably of brown over grey, is painted over the hulls and turrets; very early examples sometimes displayed a three-colour scheme in grey, green and brown. The only markings visible here are a crude black 'club' playing-card symbol on the rear trackguard flaps, presumably indicating the sub-unit. (RAC Tank Museum)**

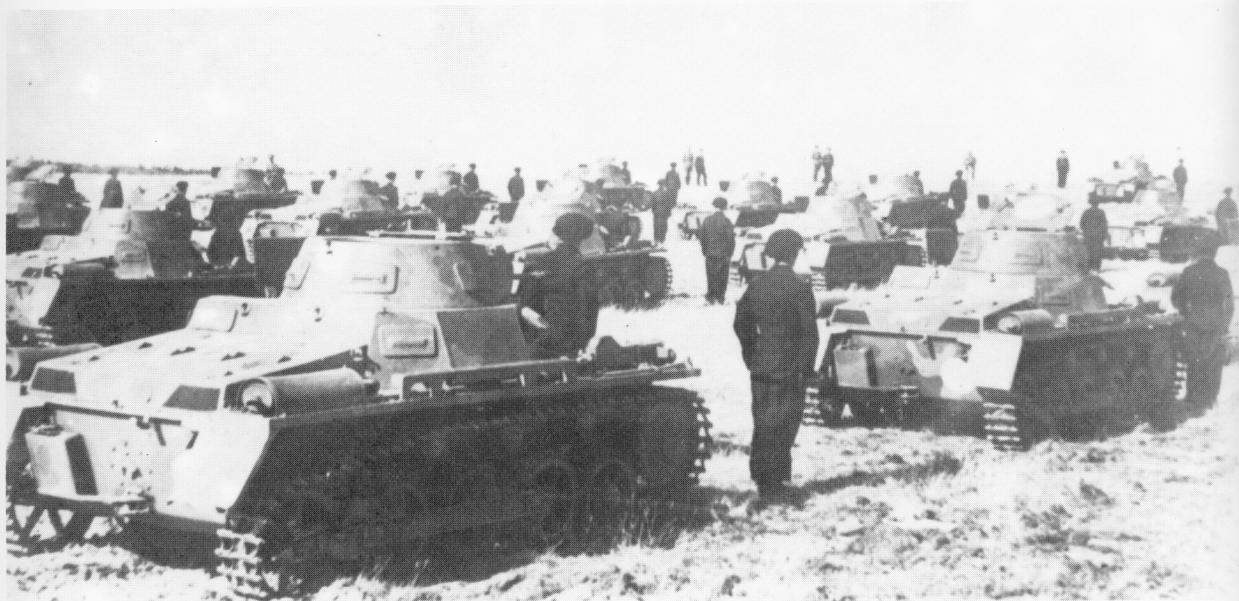
Crews and vehicles lined up for inspection at the end of a demonstration or exercise. The original print shows the playing-card trackguard symbols; and note white disc, presumably an exercise recognition device, painted at the right of the rear hull plate and on the turret hatch. The nearest tank at the right seems to display a three-colour pattern. (RAC Tank Museum)

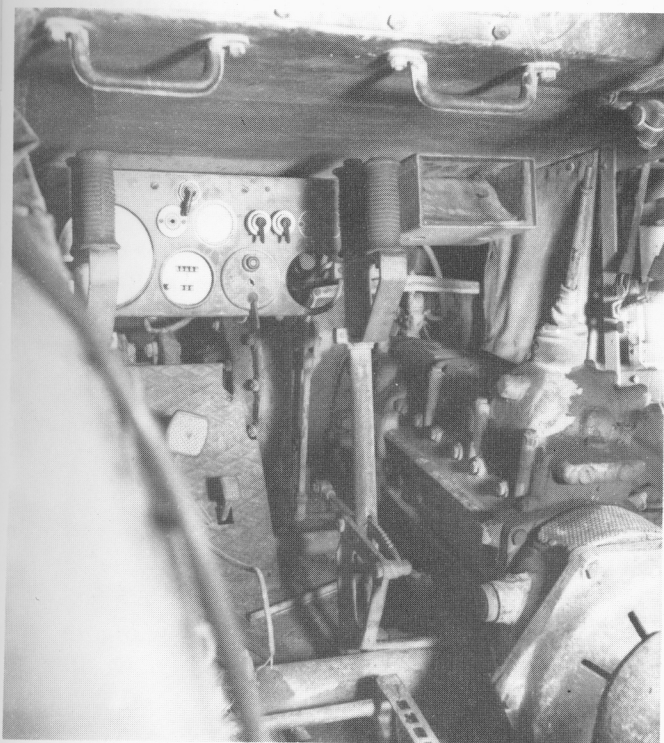
**Driver's controls and instrument panel of a PzKpfw I Ausf.A (RAC Tank Museum)**

being supplied by a small fan. The driver controlled direction by means of steering levers, each of which had two hand-grips—one for normal steering and the other with a thumb plunger to act as a parking brake; no handbrake was fitted. The instrument panel contained an oil temperature gauge; a revolution counter marked from 0–3,000rpm with a danger zone above 2,500rpm; and a speedometer marked from 0–50kph. Maximum recommended speed in gears was: 1st–5kph; 2nd–11kph; 3rd–20kph; 4th–32kph; 5th–42kph.

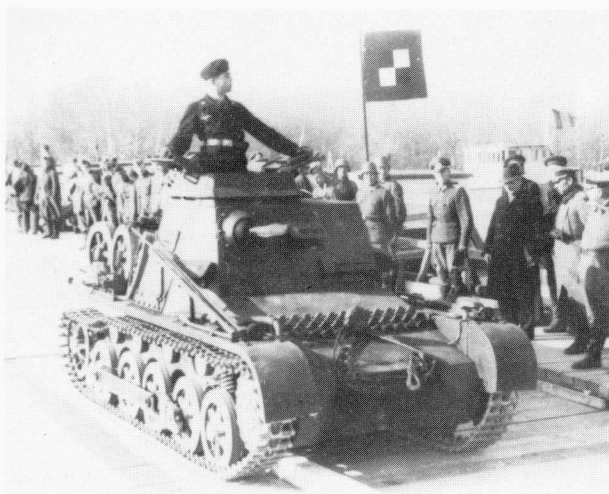
The **Kleiner Panzerbefehlswagen** (SdKfz 265) on the **Ausf. B** chassis, photographed at an **Armeeoberkommando—AOK**—in 1941. (US National Archives)

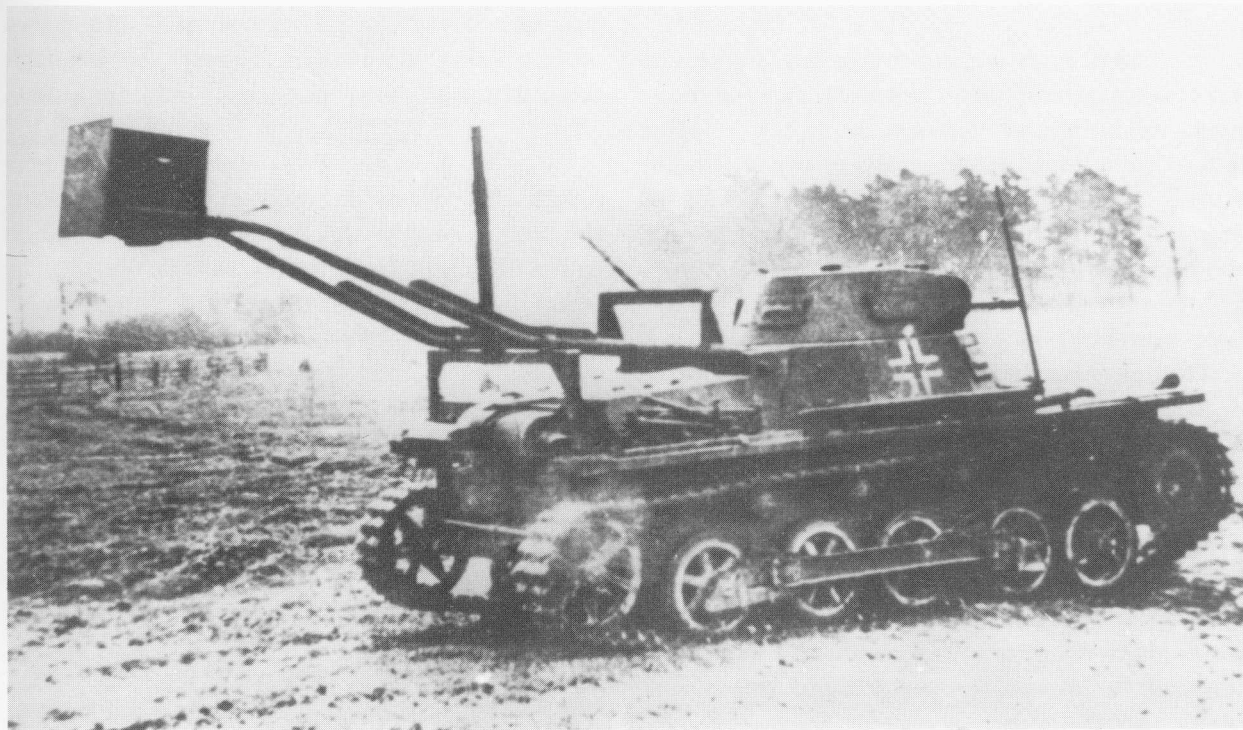
**A Ladungsleger I engineer tank, with 75kg explosive charge supported by a frame above the rear superstructure. Small numbers of these were used by the Panzer-Pionier units of the original ten Panzer-Divisionen in 1940 and 1941, but they proved too vulnerable under combat conditions. (RAC Tank Museum)**

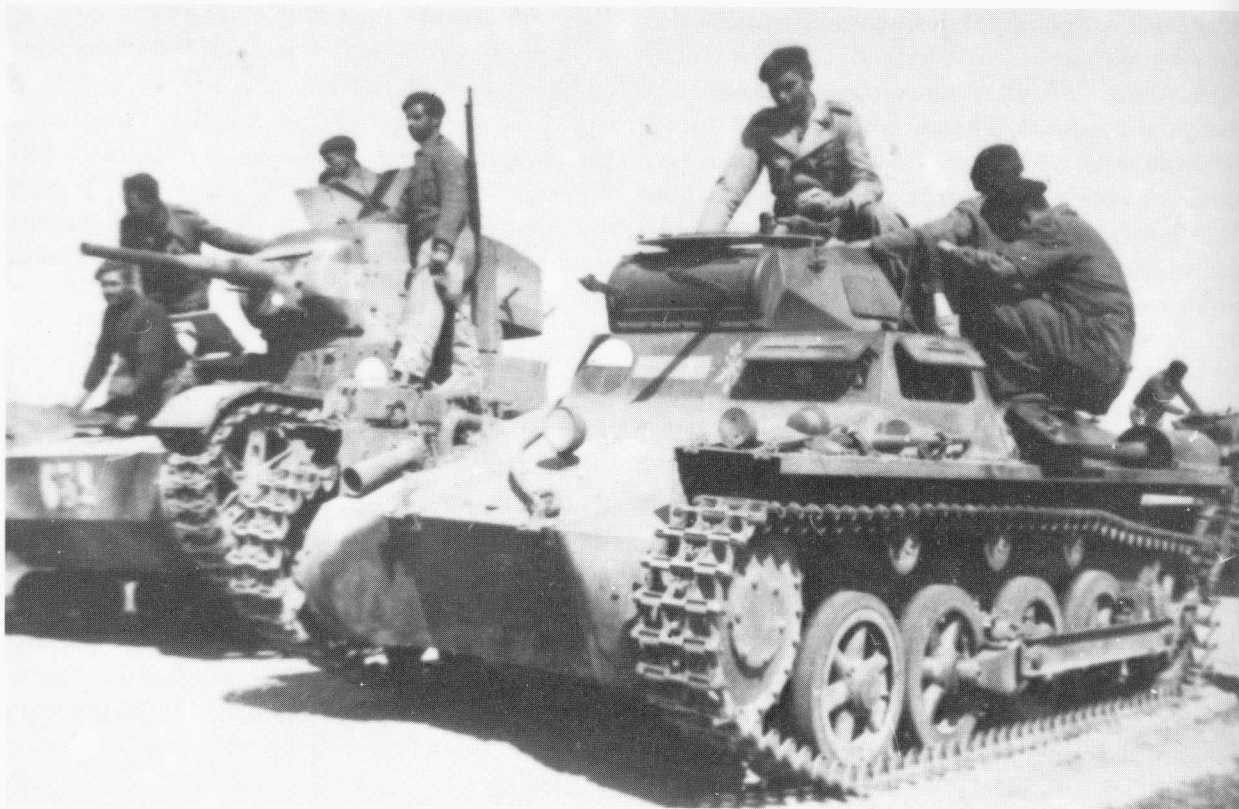
PzKpfw I Ausf.A of the 1st Company, 1st Battalion of Combat Tanks, Spanish Nationalist Army, 1938; compare markings with Plate A2. In the background, a captured Republican T-26 Model 1933; this Soviet type was greatly superior to the PzKpfw I, and captured examples were pressed into Nationalist service whenever possible. (via Steven Zaloga)

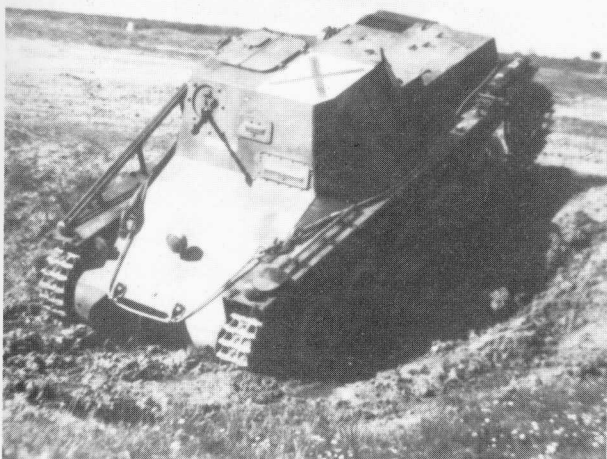
An early **Kleiner Panzerbefehlswagen**, without cupola, in service with the Legion Condor—note St. Andrew's cross, and Nationalist flag marking on hull front. The machine gun lacks the later ball mount. (via Steven Zaloga)

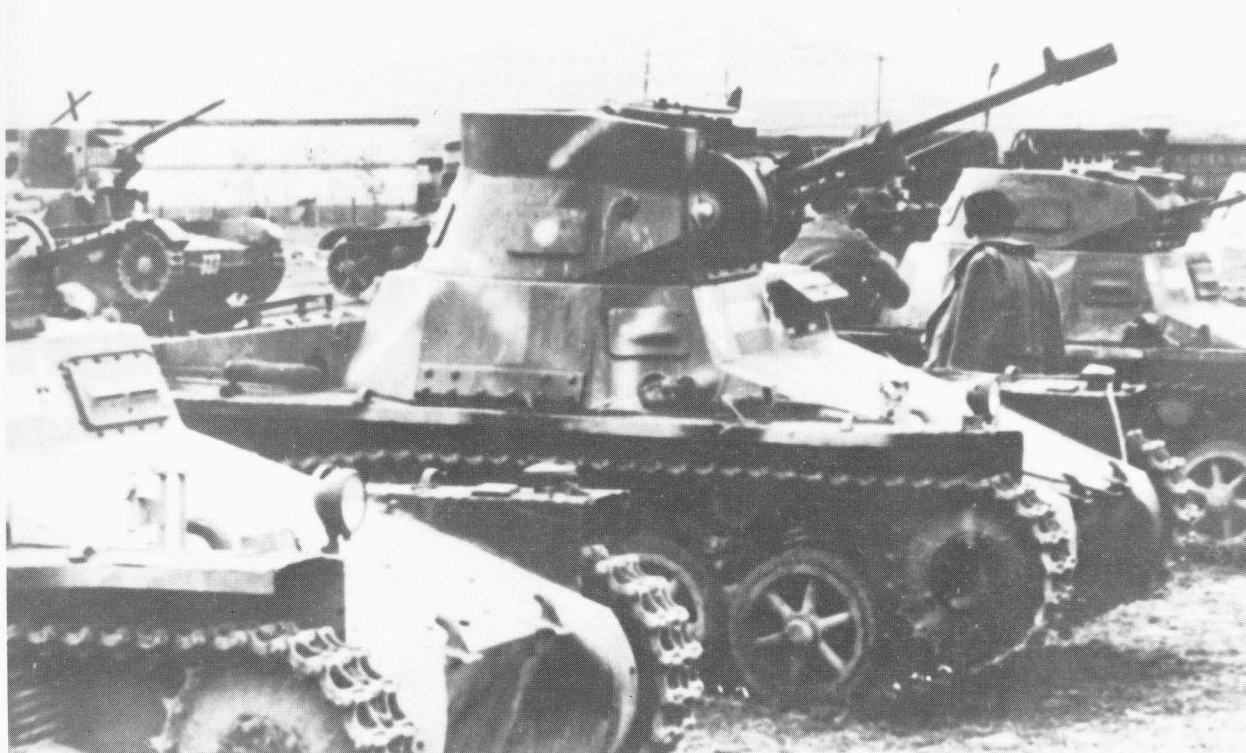
**Interesting view of one of the several PzKpfw IIs modified to mount a 20mm cannon after the battle of Sesena in Spain showed up their poor armament when faced by Soviet types. (via Steven Zaloga)**

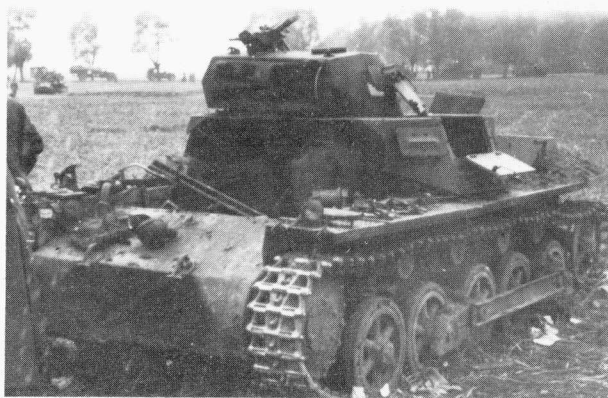
The PzKpfw I's armour was barely sufficient to protect it from machine gun fire. (Above), a tank with the hull front completely caved in by a direct hit from a Polish 75mm field gun during September 1939: 53 of the 89 PzKpfw Is lost in Poland were total combat losses. (via Steven Zaloga) (Right), a PzKpfw I Ausf. B of 4. Pz-Div. in France, 1940, also completely destroyed by an artillery hit. (US Nat. Archives)

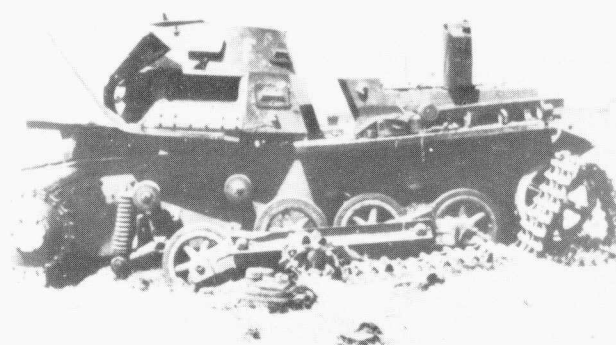
**Wespe** ('Wasp'), the official title of which was **le FH 18/2 auf Fahrgestell PzKpfw II Sf**; for reasons best understood by himself, Hitler decided that the name *Wespe* should be dropped in February 1944. This vehicle began entering service in 1942 and equipped the light batteries of Panzerartillerie regiments. It was built in substantial numbers, using most PzKpfw II chassis with the exception of Ausf. D and E. The fighting compartment, surrounded by an open-topped superstructure of armour plate, was located at the rear. A total of 32 rounds of ammunition were stowed, and the vehicle was manned by a crew of five. The L/28 howitzer was fitted with a muzzle brake and could be elevated to +42° and depressed to -5°; 17° of traverse were available either side of the centre line. A machine gun was provided for local defence.

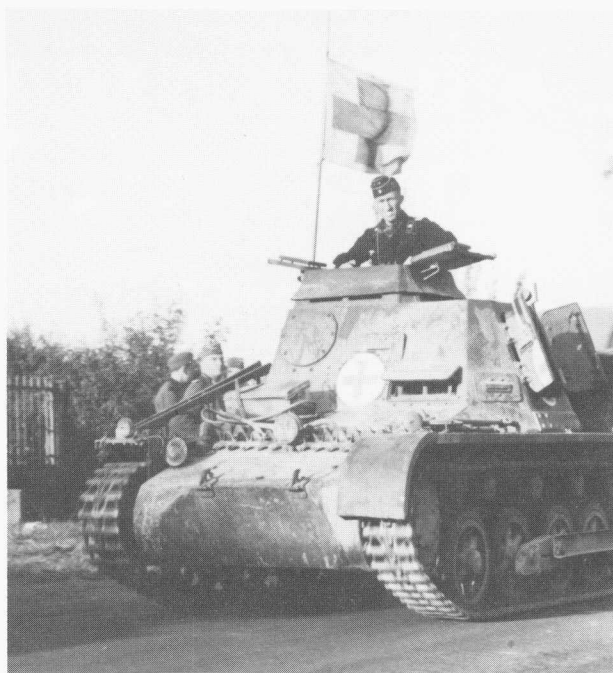
**Kleiner Panzerbefehlswagen of 4.Pz-Div. used as an ambulance vehicle in France, 1940; note red cross markings on front and sides, and divisional insignia just visible above the visor. Other ambulance conversions of the PzKpfw I had cut-down, open-topped superstructure. (US Nat. Archives)**

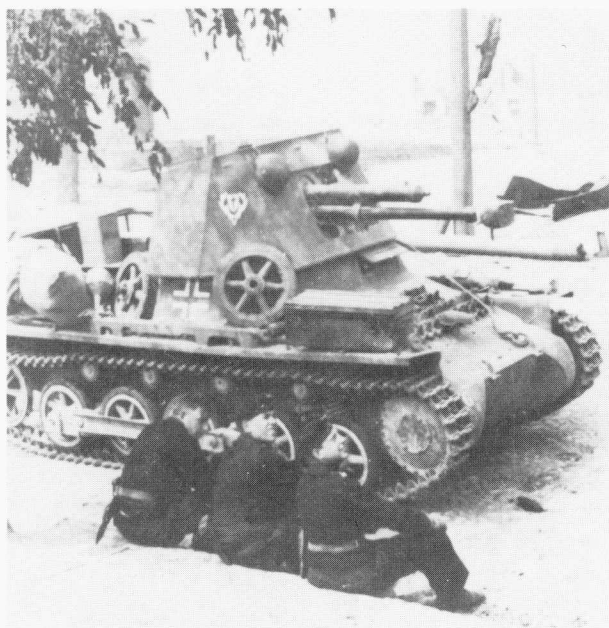
The Panzerjäger IB, photographed here during training in France in 1941; the insignia of Pz-Jäg-Abt.521 is painted in white on the shield. The mottled effect is leaf-shadow. Note helmets slung over the front of the shield. (US Nat. Archives)

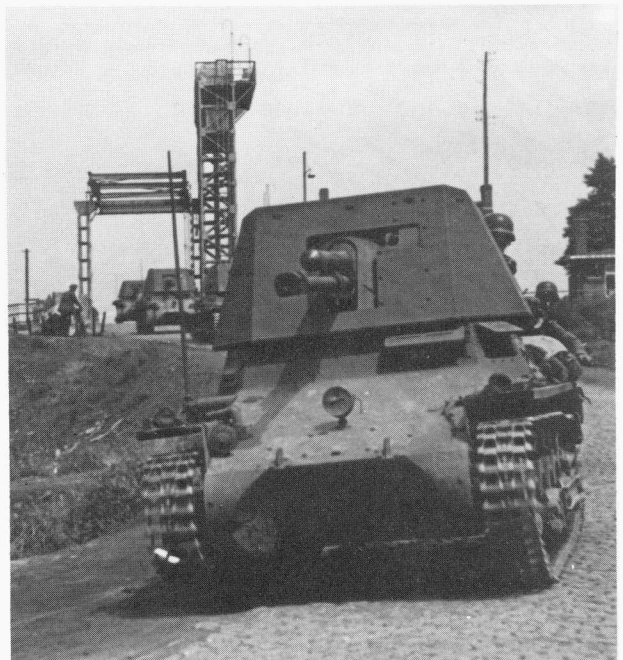
**A column of PaK 4.7cm(t) Sfl guns in Belgium, May 1940. Combining the PzKpfw I Ausf.B chassis with the potent Czech 47mm anti-tank gun in a partially protected mounting, they later served in both Russia and North Africa. (US Nat. Archives)**

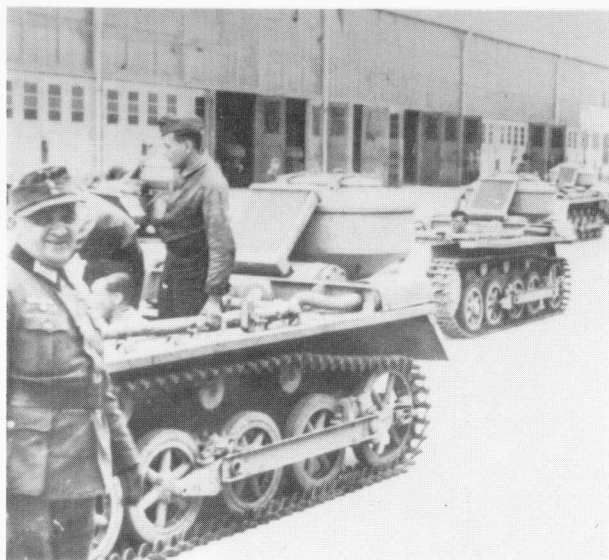
The PzKpfw I Ausf.A (LaS) was an open-topped chassis widely used by the Army and NSKK for primary driver training. These vehicles were photographed as late as 1943; note M43 cap worn by officer or official at left, 1943 dull yellow factory paint scheme, and gas generators mounted on rear decks. (US Nat. Archives)

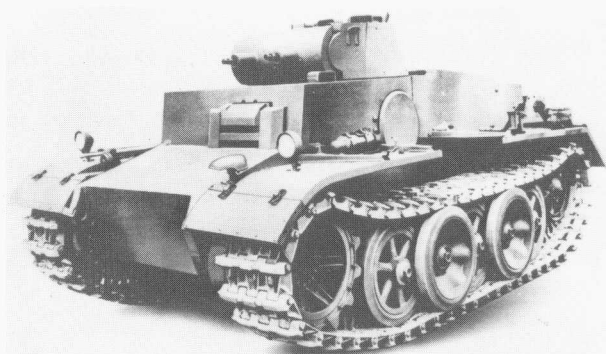
The VK 1801 was the prototype for the 'PzKpfw 1 nA verst', the up-armoured infantry support derivative; note wider tracks and interleaved suspension. (Imp. War Mus.)

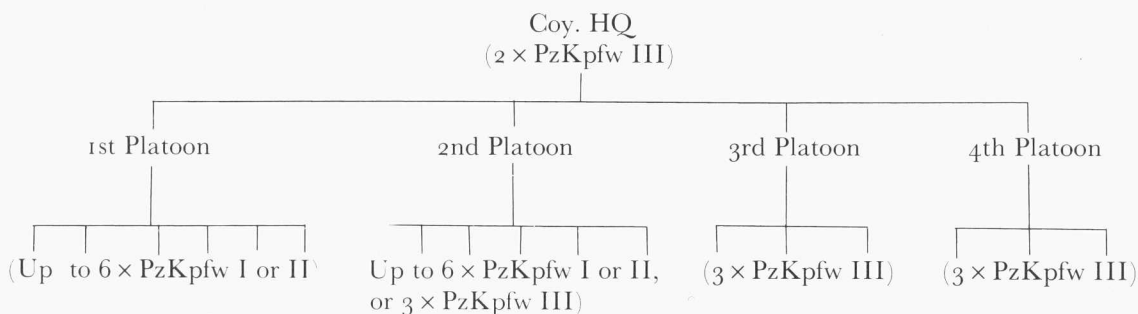
## Organization of Light/Medium Panzer Company, 1940/41\*

\*In practice organization varied widely, depending upon available equipment.

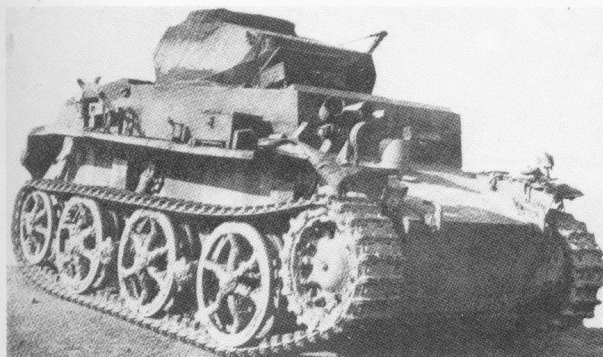
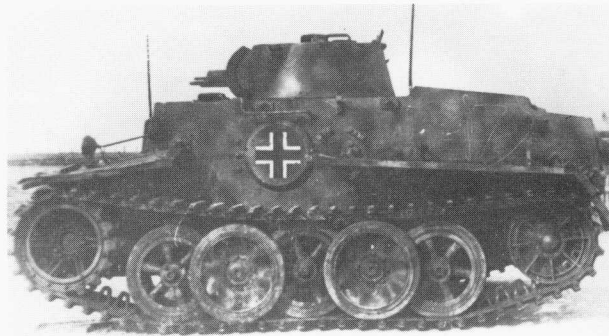
Two views of the 'PzKpfw I A verst' in service. (Above) is an interesting study of a vehicle running on a narrower track than was usually employed for this 18-ton tank, and consequently the two overlapping bogies have been removed note protruding stub axles. Beside the driver's visor is a battery of three grenade dischargers of the type later fitted to the early Tigers. (Right) is a side view of the tank captured on the Russian Front while serving with 1.Pz-Div., 'red 25'—see Plate E1. (Imp. War Mus. and J. Grandsen)

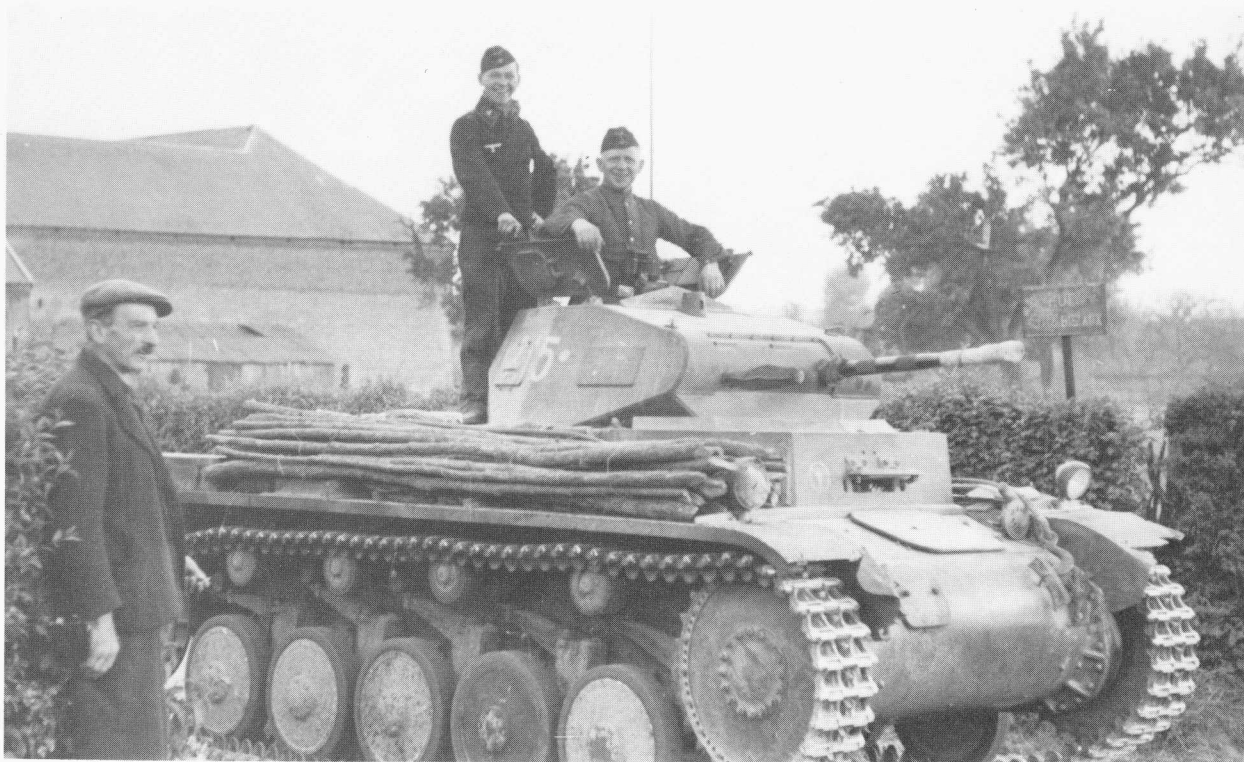
**PzKpfw II Ausf. B of Pz-Regt. 36, 4. Pz-Div. in France, 1940. The Ausf. C was the last model to be produced with the original thinly-armoured, rounded bow. Experience in Poland showed it to be vulnerable even to anti-tank rifle fire, and eventually many of the early models were retrospectively fitted with a squared-off appliqué armour kit similar in appearance to the later variants. (US Nat. Archives)**

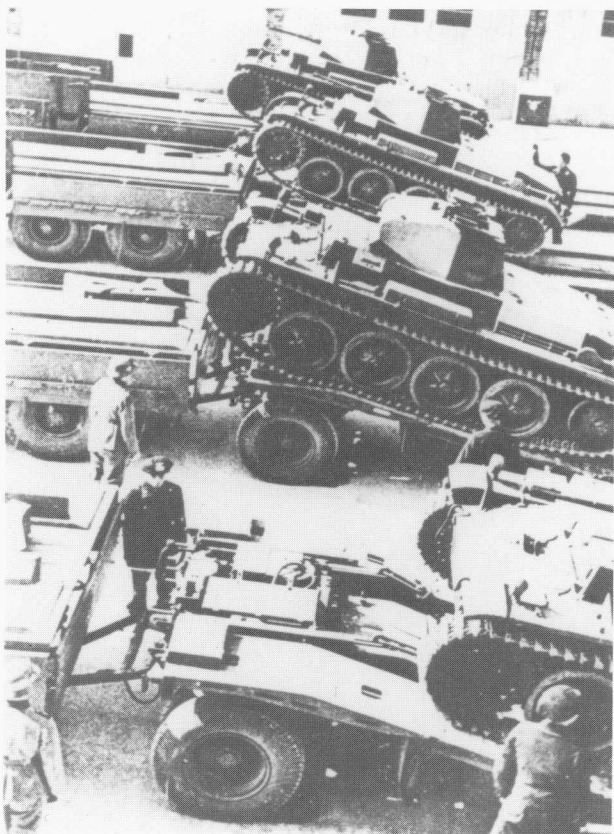
**PzKpfw II Ausf.D tanks using mobile ramps to clamber aboard their transport vehicles. One of the better features of German and Czech light tank designs was their easy portability on commercial lorries, obviating the need for expensive specialised transporters to carry them long distances outside the combat zone. (RAC Tank Museum)**

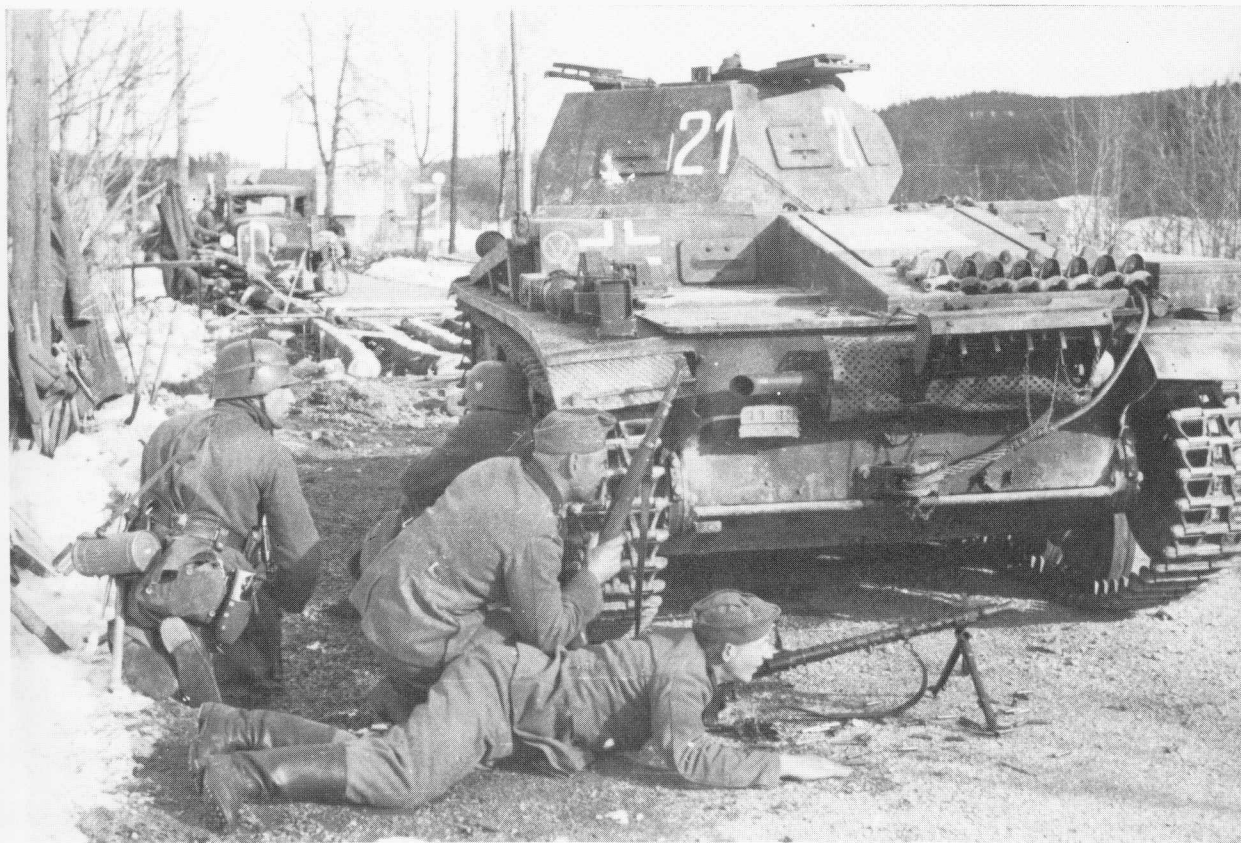
**Infantry machine-gun squad taking cover behind a PzKpfw II Ausf.B of 2.Kompanie, Pz-Abt.zBV 40 during the invasion of Norway. The battalion insignia, a yellow 'V' in a circle, can be seen left of the white outline rear hull cross. Note white rectangular air recognition panel painted on the engine deck. (US Nat. Archives)**

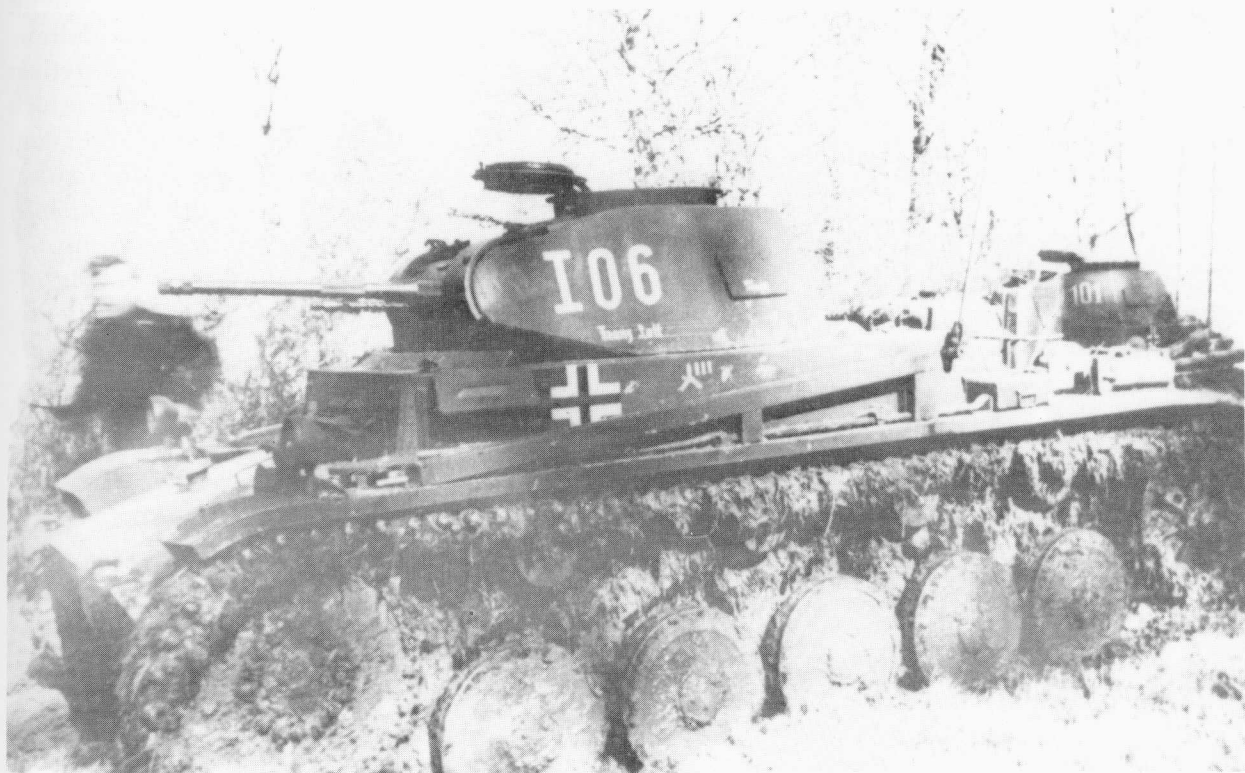
**Fully up-armoured Ausf. A, B or C photographed in North Africa, with insignia of the Deutsches Afrika Korps and 21. Pz-Div. clearly visible. Note large bolt-heads, confirming the application of extra plate to the hull and turret front; the reinforced mantlet with 'splash' plates; and the angular bow. (RAC Tank Museum)**

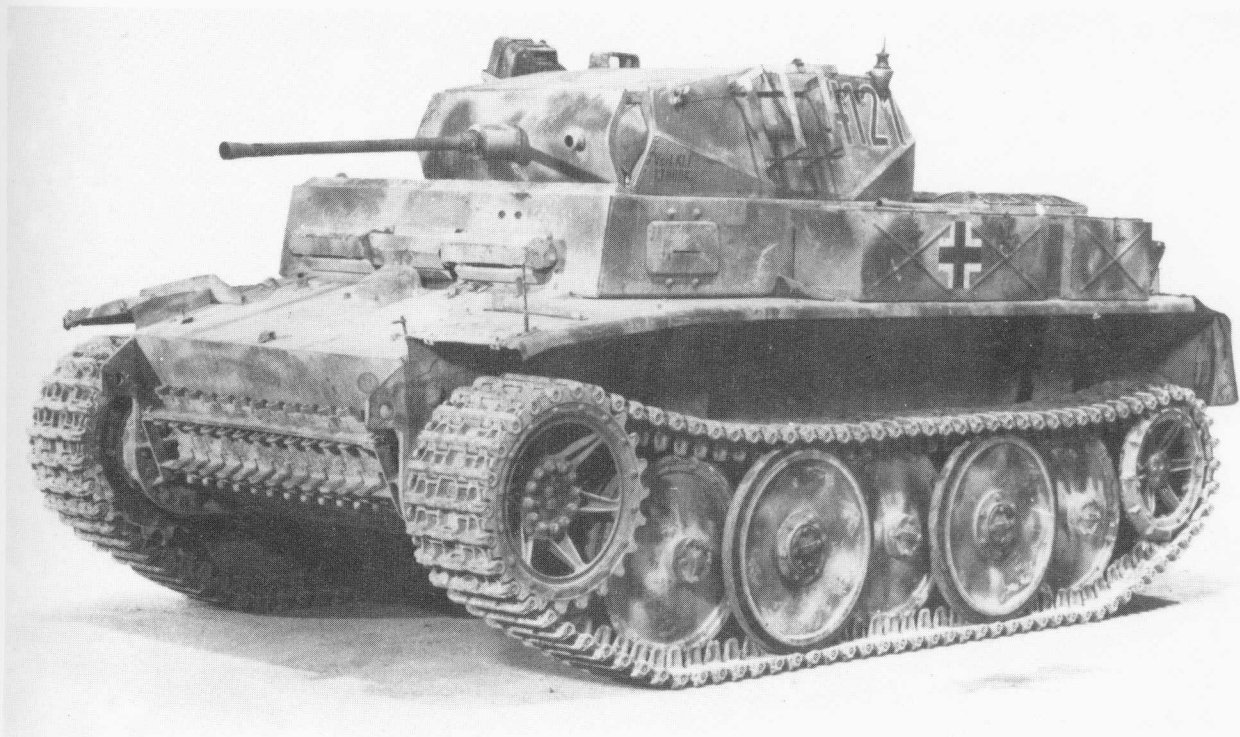
**'Lynx' armoured reconnaissance vehicle, apparently of the same unit as that in Plate E2—note turret number '4121'. Captured in Normandy, it is finished in dull yellow with brown and green random overspray. (RAC Tank Museum)**

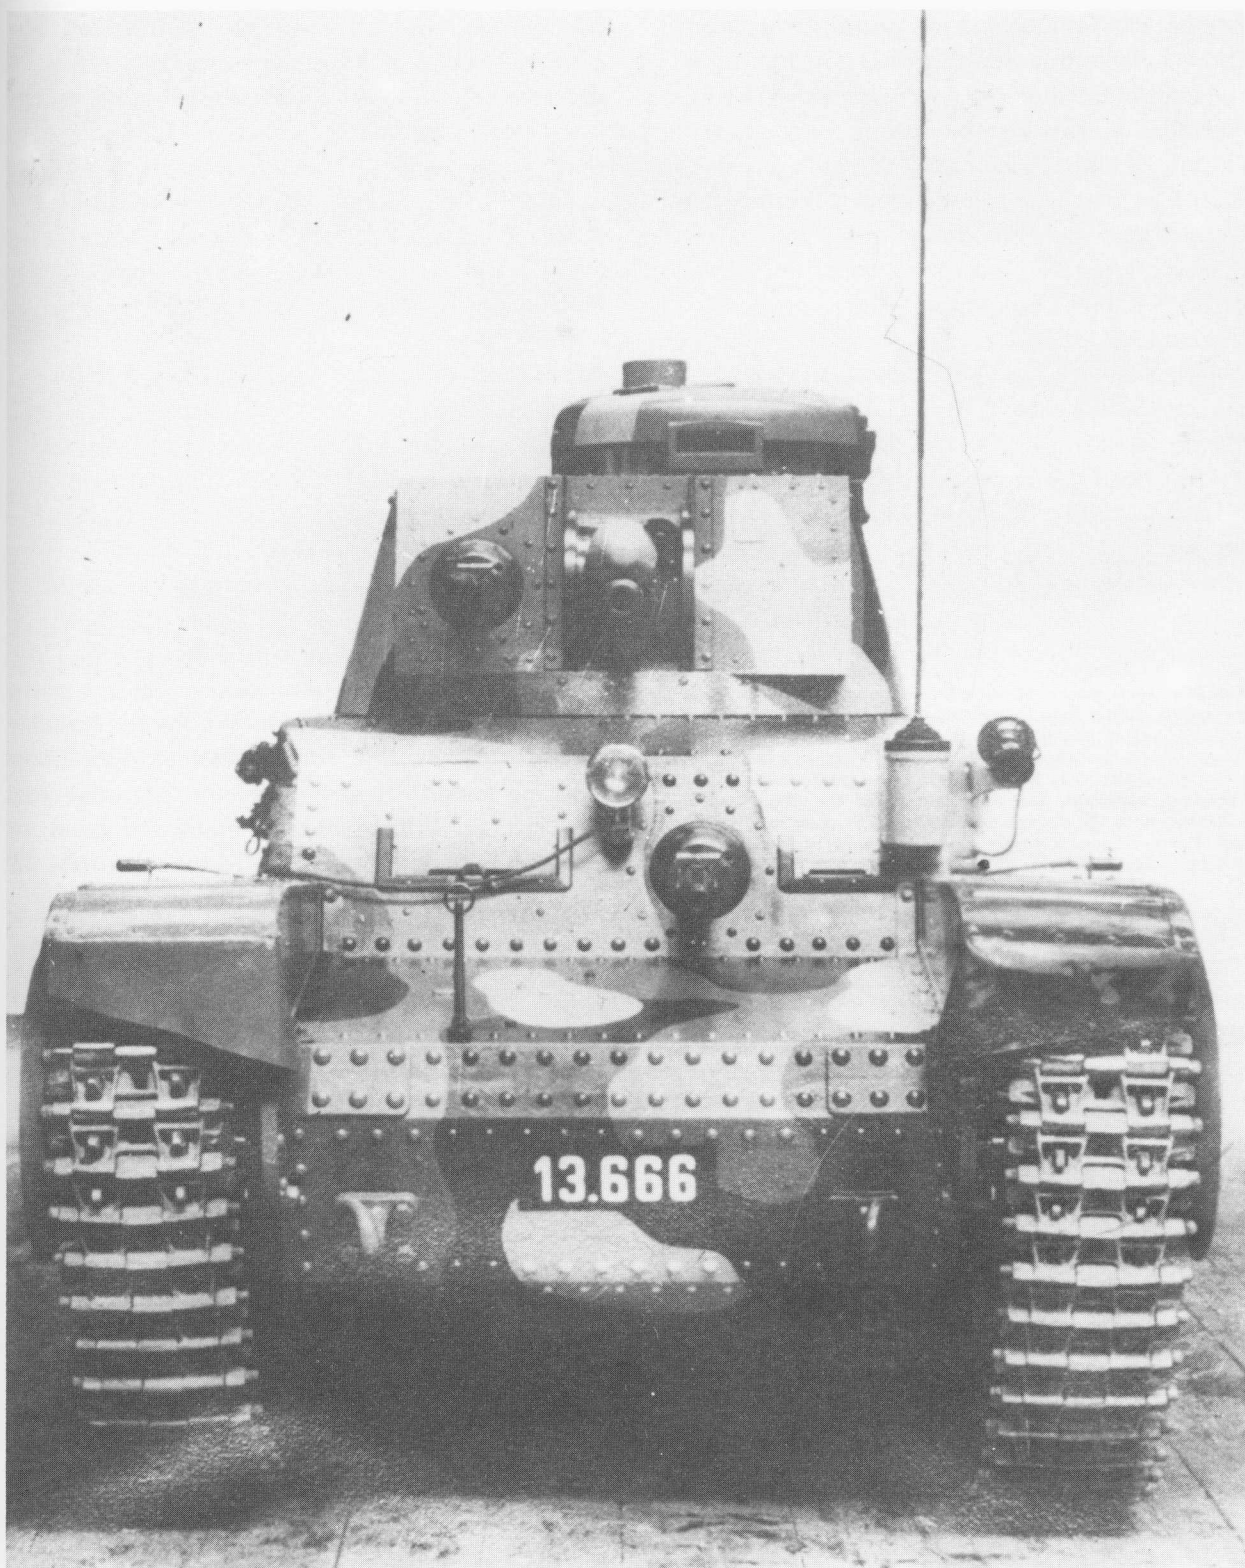
This head-on view of the PzKpfw 35(t) in its original Czech Army livery of ochre, green and brown gives a clearer idea

of the scheme seen on tanks of the Slovak Mobile Division—see Plate H2. (RAC Tank Museum)

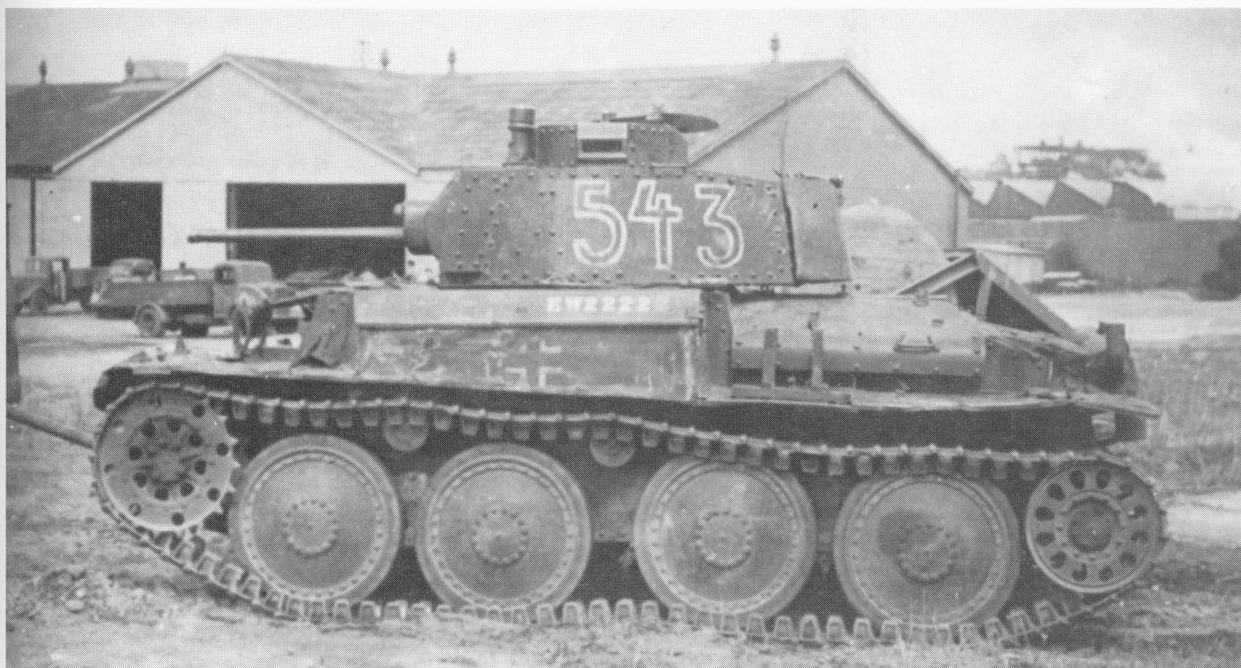
**Fine side elevation study of the PzKpfw 38(t), here a captured example to which the white serial 'EW2222' had been added. Note the commander's panoramic telescope just forward of the cupola.**

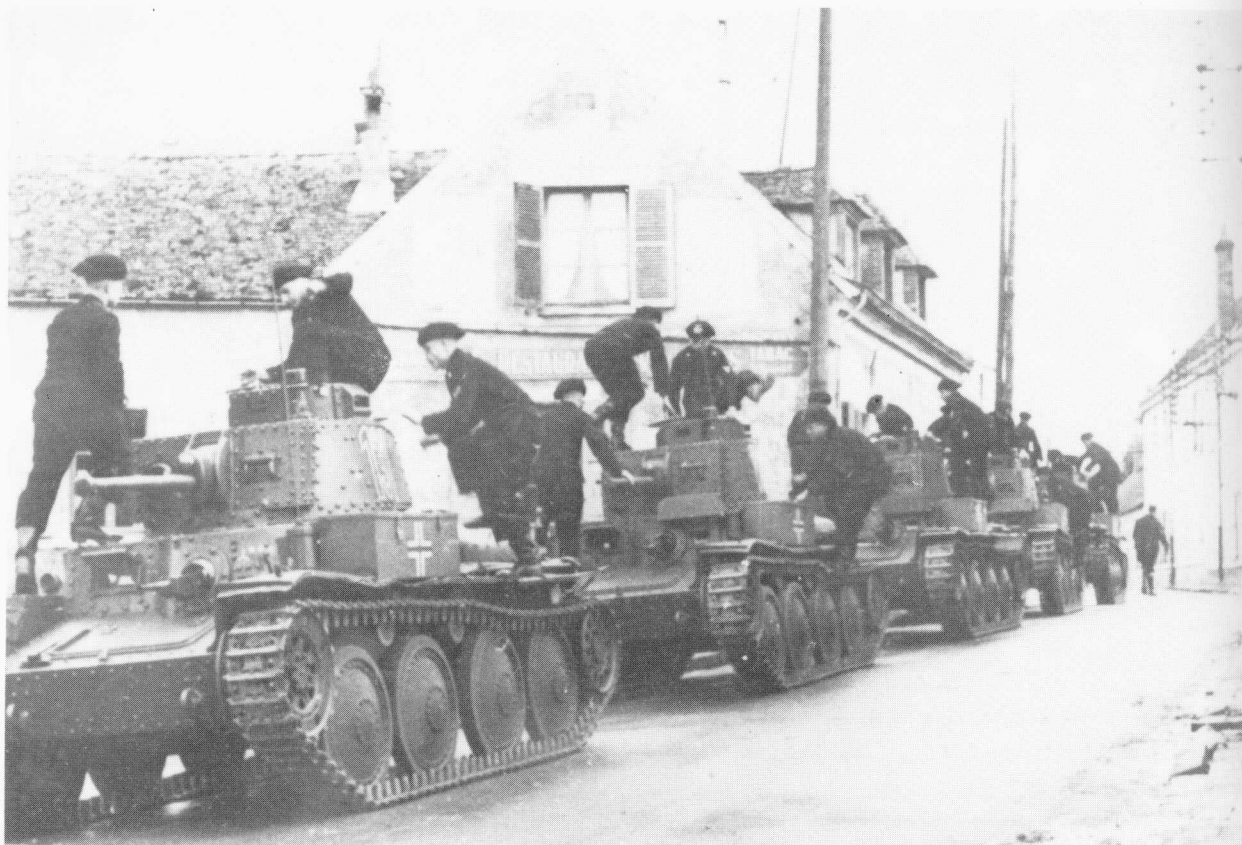
The most noted users of the PzKpfw 38(t) in 1940 were the crews of Gen. Rommel's reinforced 7.Panzer-Division. The reversed 'Y-rune' and three dots, used as the divisional sign in that campaign and visible beside the machine gun on the nearest tank here, was later changed to a simple upright 'Y' to avoid confusion with 4.Pz-Div.'s reversed 'Y' and three strokes. The turret numbers are red outlined in white, and the hull crosses black and white. (US Nat. Archives)

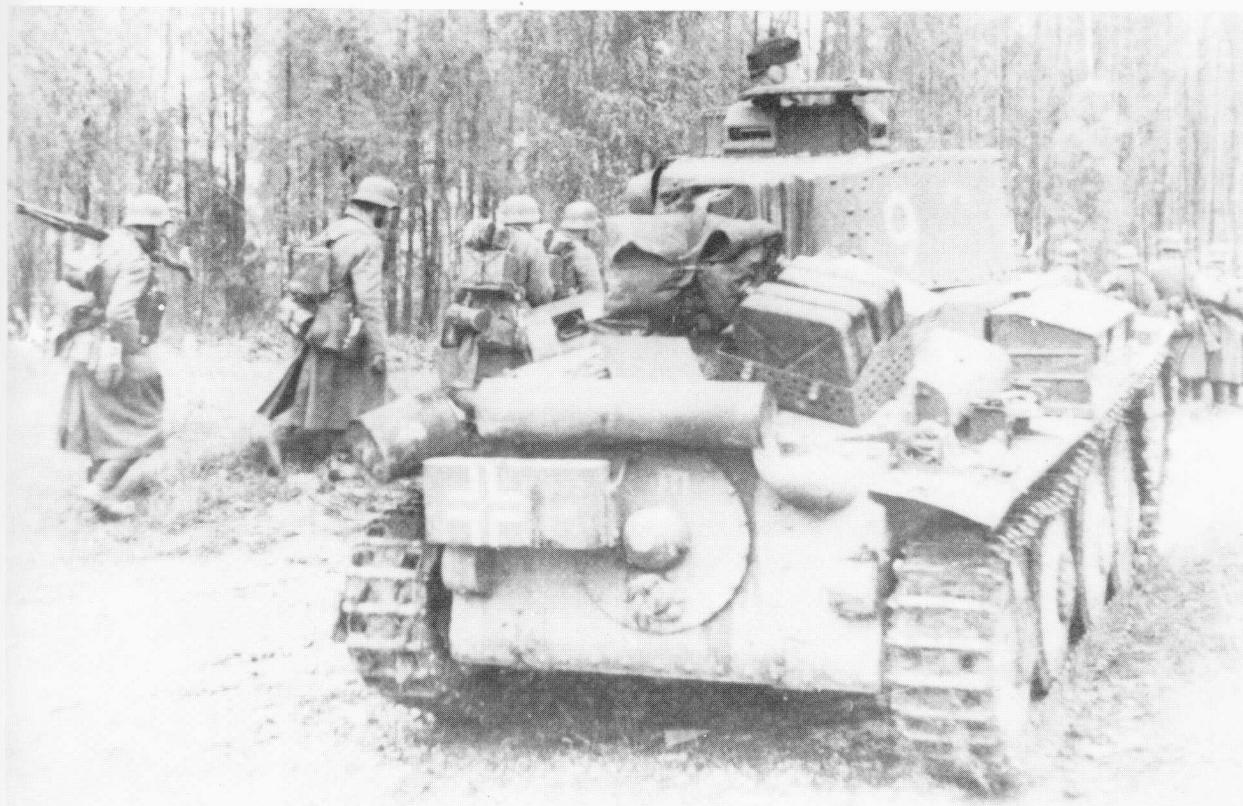
**PzKpfw 38(t) of 9.Kompanie, III Abteilung, Pz-Regt.21, 20.Pz-Div. photographed in Russia. The turret bears only the company number, in yellow; the divisional sign, a bar joining the top of three strokes, is in yellow on the rear engine access plate. This had been used in 1939–40 by 3.Pz-Div.—in an allusion to the Brandenburger Tor?—and would be dropped by 20.Pz-Div. in 1942. (US Nat.Archives)**

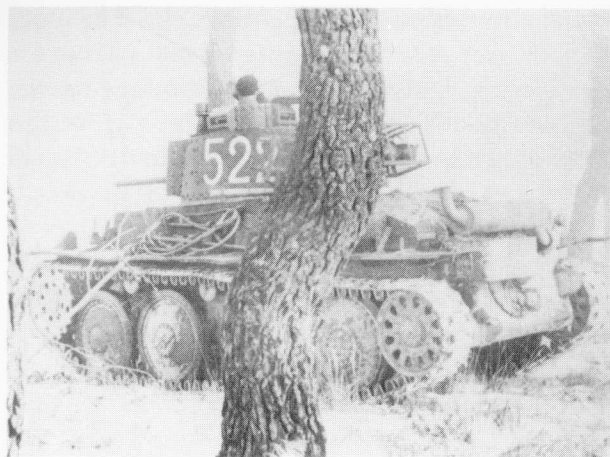
**PzKpfw 38(t) of Pz-Regt.204, 22.Pz-Div., which served in Russia only from February 1942 until it was virtually annihilated at Kalach that November, and was not re-formed. On the original the divisional sign—a yellow arrow pointing diagonally up and right, crossed by two short vertical strokes—is visible on the plate immediately below the exhaust. The turret number '522' has a bar beneath it, both being in white. Note that this crew have welded quite a large stowage rack of iron strip to the rear of the turret. (US Nat. Archives)**

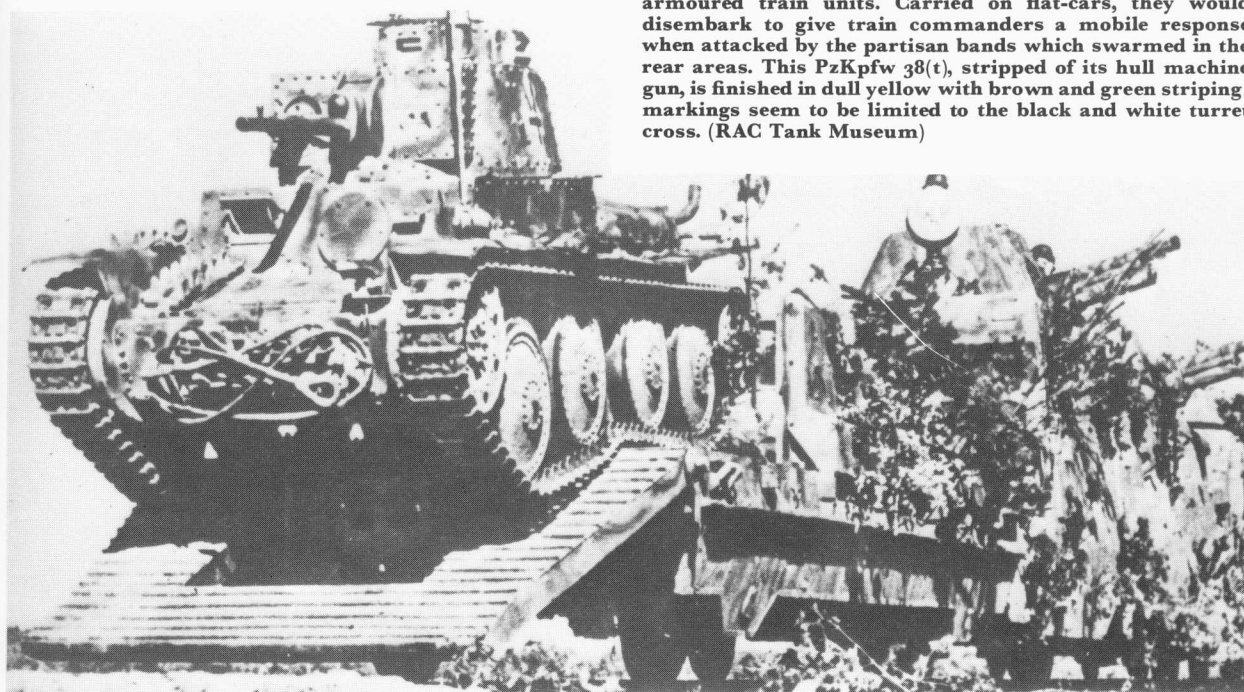
**A reminder that surviving but obsolete tanks, both German and foreign, were not wasted. Many were issued to training units, or second line units deployed on peaceful occupation duties in NW Europe. Others were stripped of their turrets and re-worked as SP guns of many kinds. On the Eastern Front many French, Czech, and other models were issued to armoured train units. Carried on flat-cars, they would disembark to give train commanders a mobile response when attacked by the partisan bands which swarmed in the rear areas. This PzKpfw 38(t), stripped of its hull machine gun, is finished in dull yellow with brown and green striping; markings seem to be limited to the black and white turret cross. (RAC Tank Museum)**
