*Evaluation of the 17 June 1997
Criticality Accident at Arzamas-16*

EVALUATION OF THE 17 JUNE 1997 CRITICALITY ACCIDENT AT ARZAMAS-16

Abstract

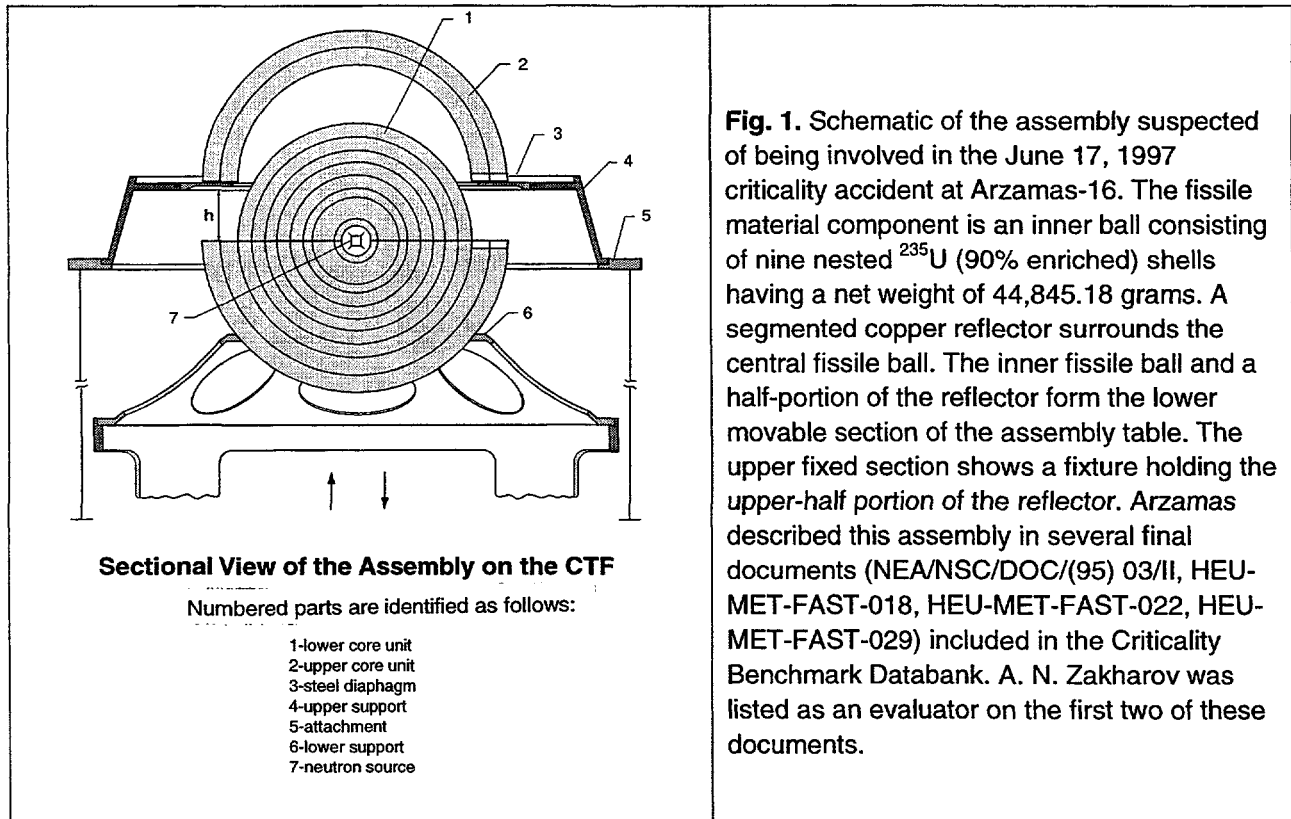
Fig. 1. Schematic of the assembly suspected of being involved in the June 17, 1997 criticality accident at Arzamas-16. The fissile material component is an inner ball consisting of nine nested ²³⁵U (90% enriched) shells having a net weight of 44,845.18 grams. A segmented copper reflector surrounds the central fissile ball. The inner fissile ball and a half-portion of the reflector form the lower movable section of the assembly table. The upper fixed section shows a fixture holding the upper-half portion of the reflector. Arzamas described this assembly in several final documents (NEA/NSC/DOC/(95) 03/II, HEU-MET-FAST-018, HEU-MET-FAST-022, HEU-MET-FAST-029) included in the Criticality Benchmark Databank. A. N. Zakharov was listed as an evaluator on the first two of these documents.

We suspect that the assembly machine involved in the accident resembles the machine illustrated in Figure 1. A section of the support bracket, labeled 3 and 4 in the figure, was either not in place and he was using spacers or if it was in place the separation distance, labeled h, was too small to prevent the assembly from reaching prompt critical. For some reason the mechanism to scram the system did not function as designed. Perhaps it was disengaged or perhaps the entire assembly fell and the copper shells partially melted to the shims. In any event, the system did not scram properly, and the assembly remained in a critical state until physically dismantled. These factors are described in more detail in Section II.

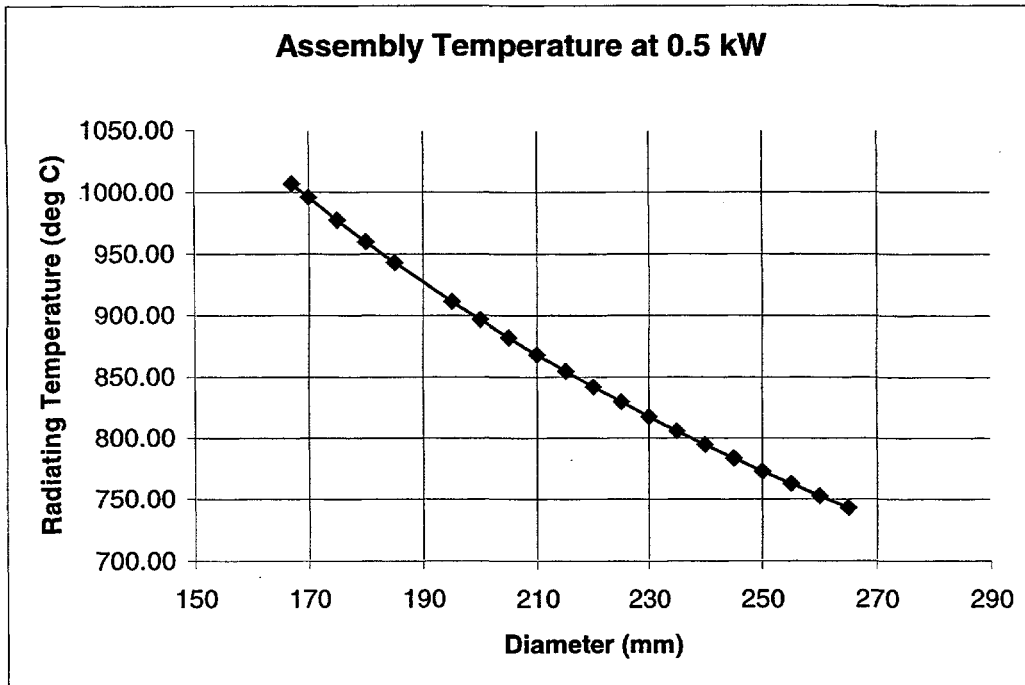
Fig. 2. The dependence of internal temperature on size for a spherical, solid ball radiating one-half kilowatt of power to normal room temperature. The outer surface is assumed to be slightly oxidized copper (emissivity=0.15). Our criticality calculations indicate that the outside copper reflector diameter lies between 167 mm and 202.5 mm (see text).

The assembly remained critical for six days following the initial burst. One report stated that it was radiating at a power level of about 0.5 kW. If we ignore thermal conduction and assume that the copper was slightly oxidized (emissivity=0.15), then the assembly temperature was between 800 and 1000°C (see Fig. 2). Because copper melts at a temperature of 1,083°C, we suspect that at the time of the accident some melting of the copper shell occurred. The high temperature and the partial melt probably complicated the efforts of the facility managers to disassemble the critical unit.

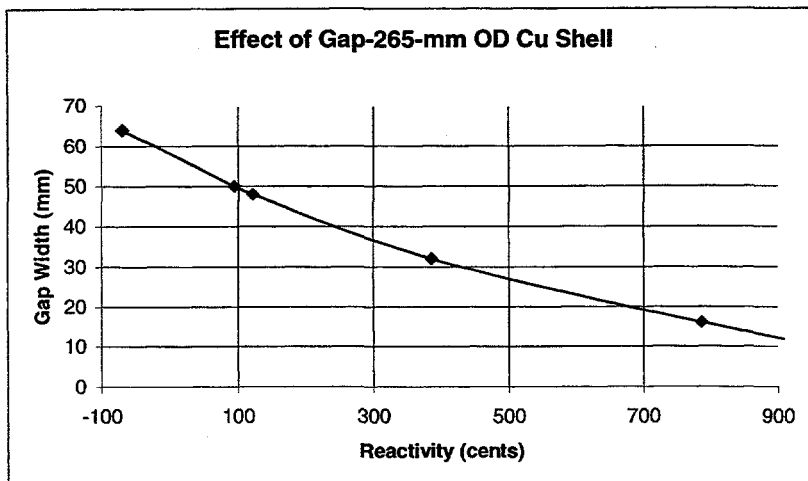
Fig. 3. Results from a ONEDANT calculation that simulated the effect of a gap in the outer copper reflector upon reactivity.²³ The configuration's nominal outside diameter with no gap is 265 mm. Reactivity is measured in cents, where $\beta_{\text{eff}} = 0.007$.

To explore how reactive possible assembly configurations were, we ran a series of ONEDANT calculations. The calculations included an air gap between the upper and lower sections of the outer copper shell. Results are shown graphically in Figures 3 and 4.

Figure 3 is a plot of the gap width as a function of reactivity for the 265-mm shell. For this configuration, we expect the critical assembly to be prompt critical (reactivity at 100 cents) at an approximate spacing of 50 mm, and to vaporize at a spacing closer than 48 mm (reactivity of 120 cents.)

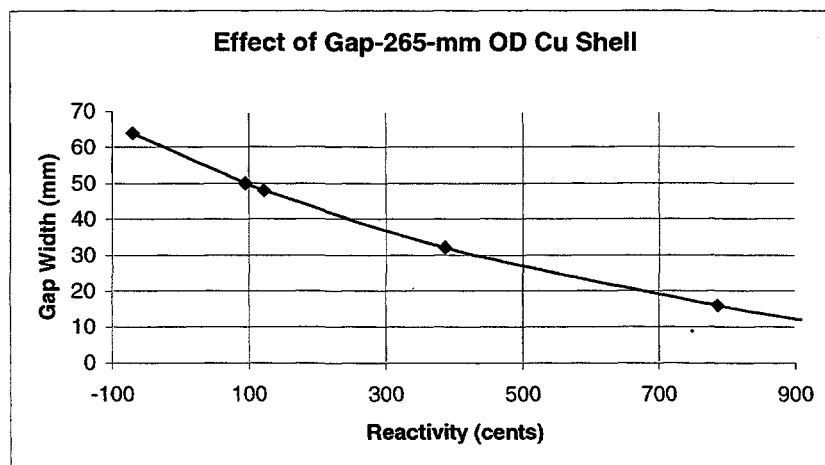
Fig. 4. Results from a ONEDANT calculation that simulated the effect of a gap in the outer copper reflector upon reactivity.²⁴ The configuration's nominal outside diameter with no gap is 205 mm. Reactivity is measured in cents, where $\beta_{\text{eff}} = 0.007$.

Figure 4 shows similar behavior for a 205-mm outer diameter shell. For this case, vaporization will occur at a gap spacing closer than 4 mm. This configuration is to be contrasted with the summary work statement for Experiment 17 (see page 3 Appendix 1). With the 205-mm diameter outer copper reflector, the assembly has a multiplication of 131 at a separation of 2 mm.

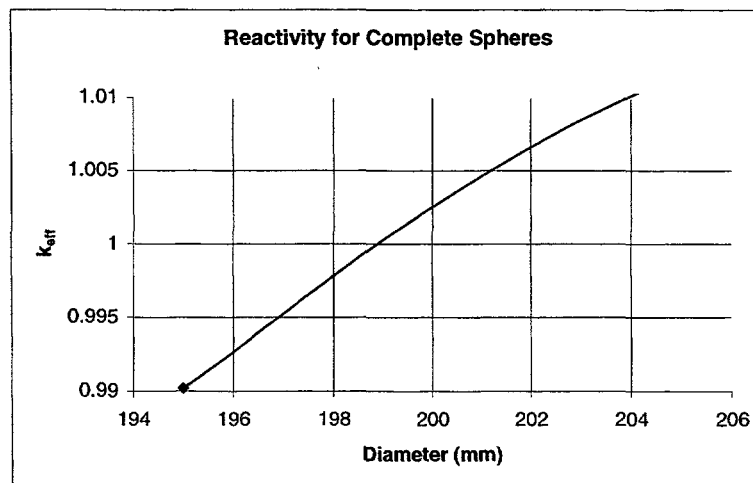
Fig. 5. Graph of Monte Carlo calculation to show how k_{eff} for the assembly depends upon the diameter (thickness) of the copper reflector. The core surrounded by the reflector is a spherical ^{235}U (90% enriched) annular ball. Its internal diameter is 28 mm and its external diameter is 167 mm.

We continued the study and used interpolation on a bracketing series of MCNP Monte Carlo k-calculations. Compositions for the inner ^{235}U (90% enriched) ball were taken from a final report in the Handbook on an equivalently sized ball that VNIIEF personnel submitted in August 1996 to the ICSBEP.²⁵ This ball has a 28-mm-diameter internal void and a 167-mm outer diameter. The study (see Fig. 5) indicates that if the assembly were a complete sphere with upper and lower sections having the same diameter, then the outer diameter of the copper shell could not have exceeded 202.5 mm.

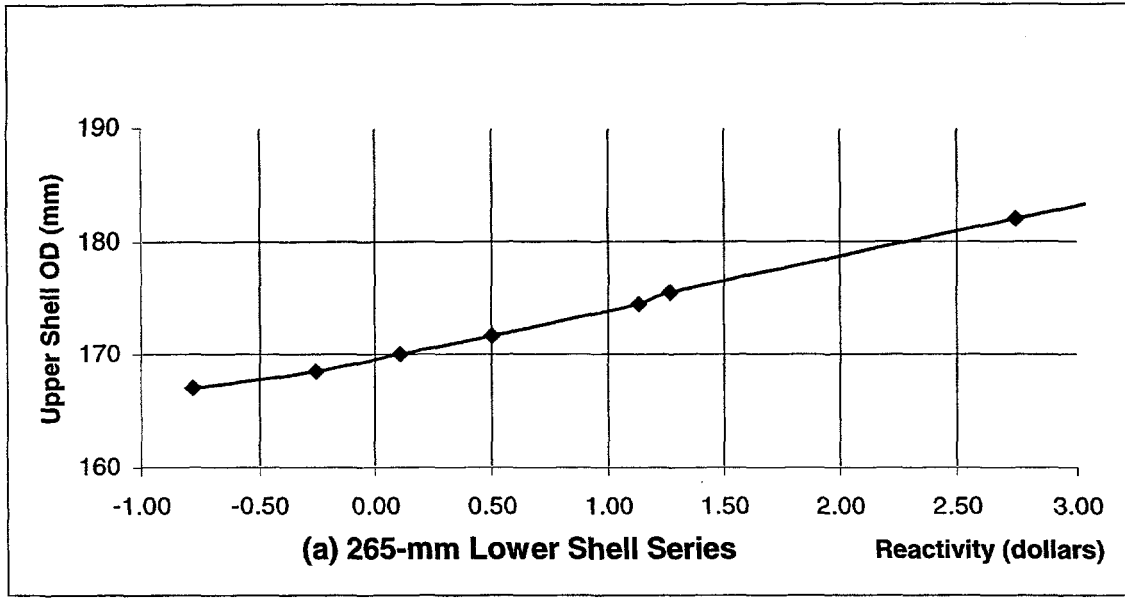
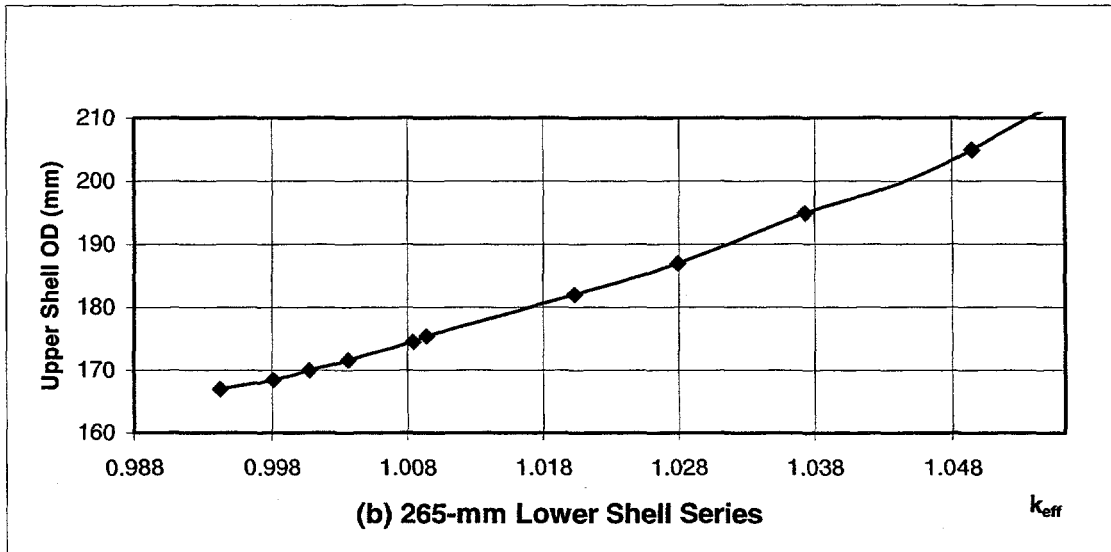
Fig. 6. Graph of Monte Carlo calculation indicating how (a) the reactivity ($\beta_{eff} = 0.007$) and (b) k_{eff} of an assembly reflected by a split copper reflector depends upon the diameter of the upper section. The lower section diameter is held constant at 265 mm. The sections are closed with no gap. The effect of a 2-mm gap is to reduce reactivity about 50-58 cents. The core is a spherical ^{235}U (90% enriched) annular ball. Its inside diameter is 28 mm; its external diameter is 167 mm.

Using the same ^{235}U (90% enriched) ball described above, we explored with MCNP the reactivity of assembly configurations in which the lower section is a copper reflector shell with outside diameter equal to 265 and the upper section is a copper shell of smaller diameter. We present a summary of results in Table I and Figure 6. From Figure 6 we infer that to remain below prompt critical, the maximum outside diameter for the upper shell is 174.5 mm with no separation, and about 177 mm with a 2-mm gap. These shells weigh 3 to 5 pounds. Use of a thicker shell would have increased the reactivity above prompt critical.
