## Field Feature Bill of Material (FFBM)

**PN 80G2807**

### **Replace TRP Processor (FC 5600) with TRP2 (FC 5622) in IBM 3746 Models 9X0**

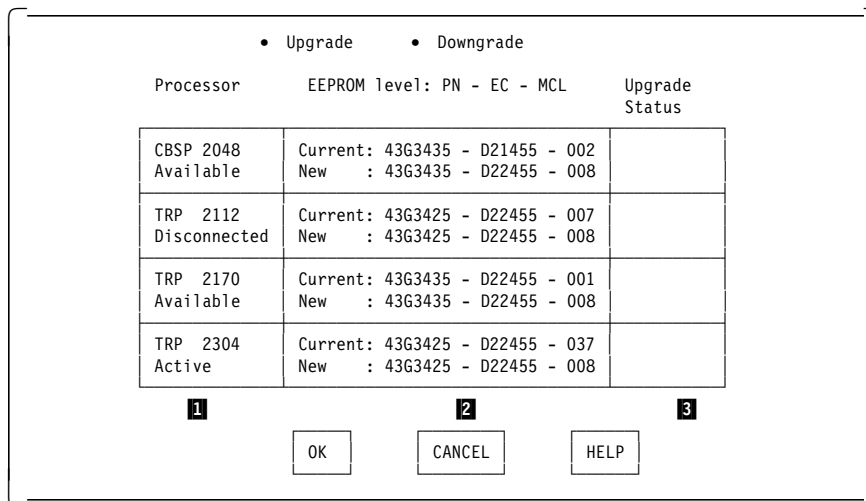
Figure 3. Example of An EEPROM Upgrade Window

Processor	EEPROM level: PN - EC - MCL	Upgrade Status
CBSP 2048 Available	Current: 43G3435 - D21455 - 002 New : 43G3435 - D22455 - 008	
TRP 2112 Disconnected	Current: 43G3425 - D22455 - 007 New : 43G3425 - D22455 - 008	
TRP 2170 Available	Current: 43G3435 - D22455 - 001 New : 43G3435 - D22455 - 008	
TRP 2304 Active	Current: 43G3425 - D22455 - 037 New : 43G3425 - D22455 - 008

- 1** Gives the list of the 3746-9x0 processors in CDF-E with their status (available/disconnected/active).
- 2** Gives the current and new EEPROM level: PN/EC/Level of each processor.
- 3** Gives the status after the activation of the function.
- \_\_\_ 3. According to the action that you want to do, click on **"Upgrade"** or **"Downgrade"** option on the top of the screen, then click on **OK**.  
 An "EEPROM Upgrade" window informs you that the EEPROM upgrade or downgrade is in progress with its time duration.  
 At the end, a status is displayed for each processor.
- \_\_\_ 4. Check the result of your EEPROM upgrade/downgrade operation with the following table and take the appropriate action:

- \_\_\_ 1. On the **3746-9x0 Menu** window click on **Change Management**.
- \_\_\_ 2. Double click on the **Upgrade/Downgrade EEPROM Code Level**.  
 A window is displayed with a message box saying that the service processor is searching the 3746-9x0 configuration.  
 On **EEPROM Upgrade** window, the processors subject to upgrade or downgrade are **highlighted** according to the preselected status of the options "Upgrade" or "Downgrade" on the top of the window (see Figure 3).
